ALL-WEATHER ACCESS ROAD (AWAR)

APPENDIX S

ITIVIA FUEL STORAGE AND BYPASS ROAD

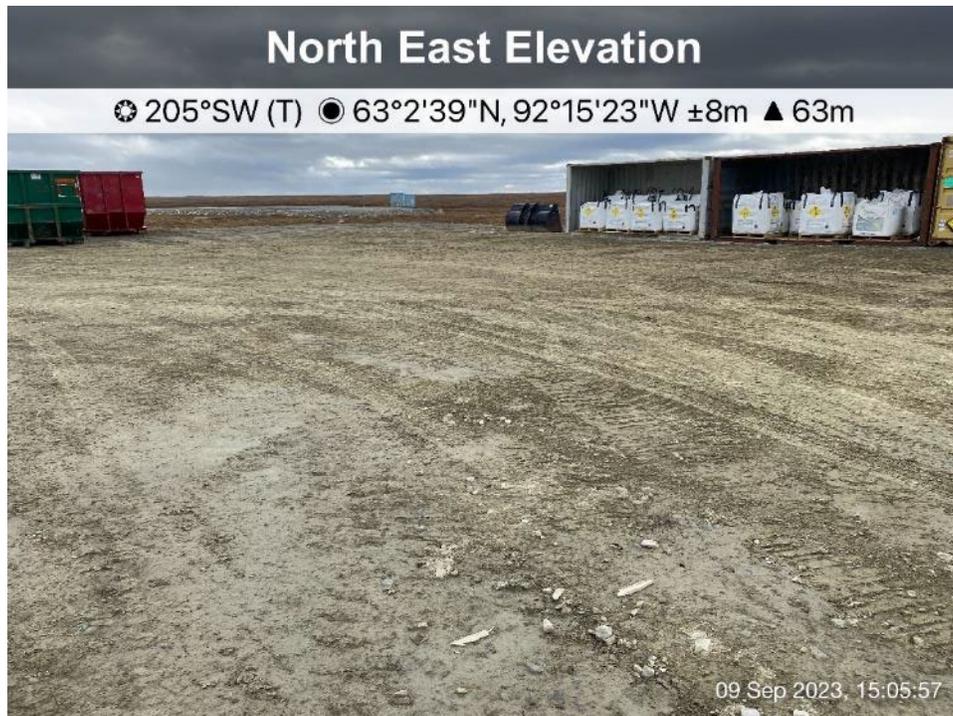
Emulsion Plant Pad - Photo 16: Emulsion Plant Pad - Overview, looking southwest.

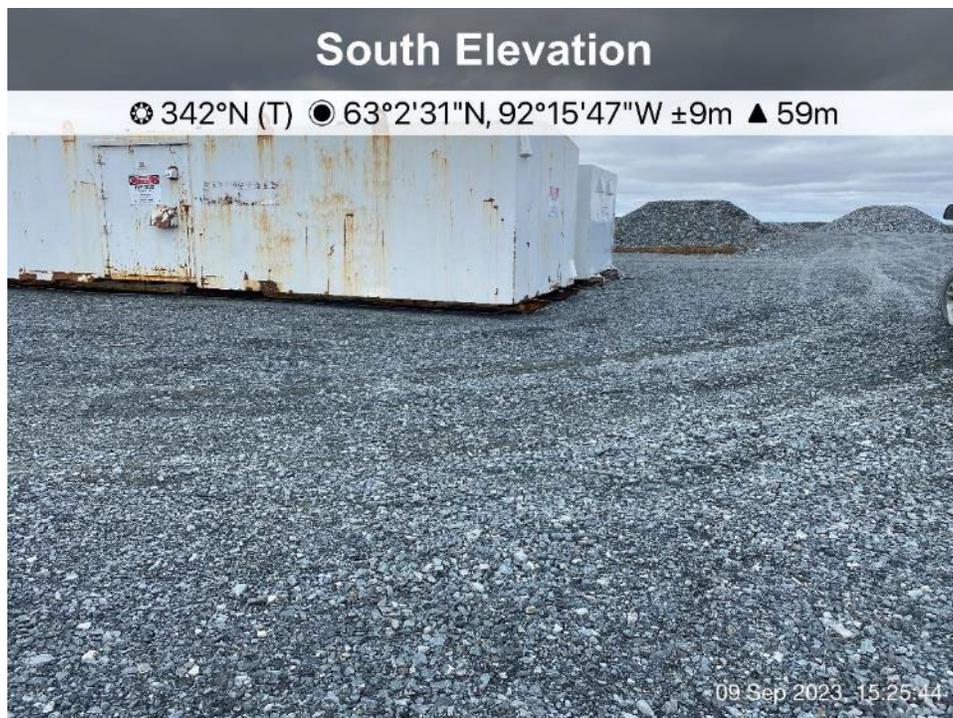
Emulsion Plant Pad - Photo 17: Emulsion Storage Pad- Overview, looking north.

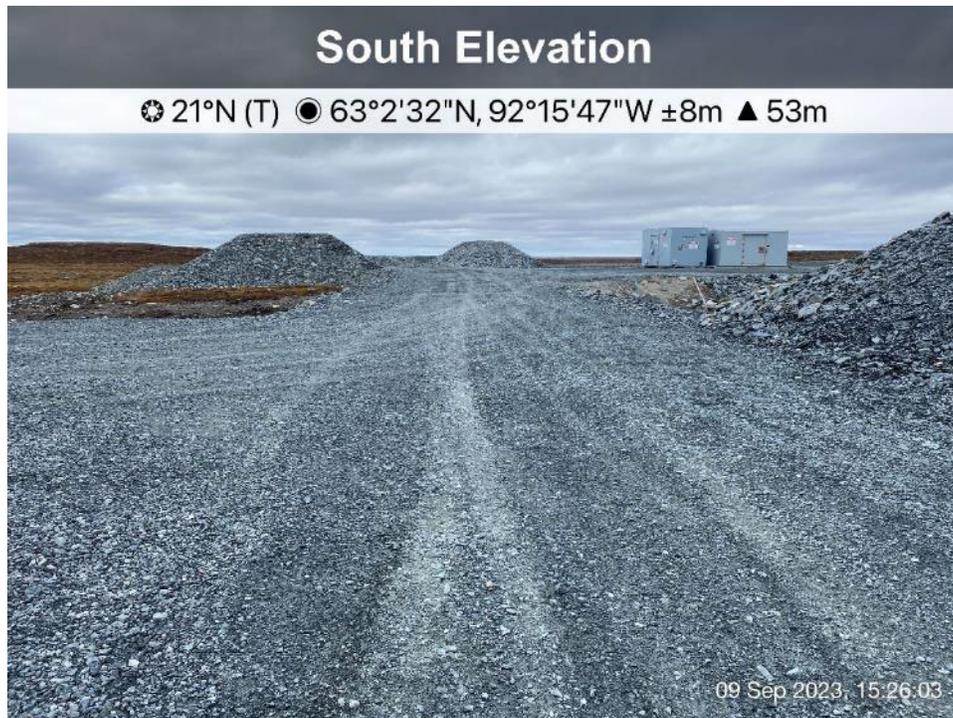
Emulsion Plant Pad - Photo 18: Emulsion Storage Pad - Overview, looking north.

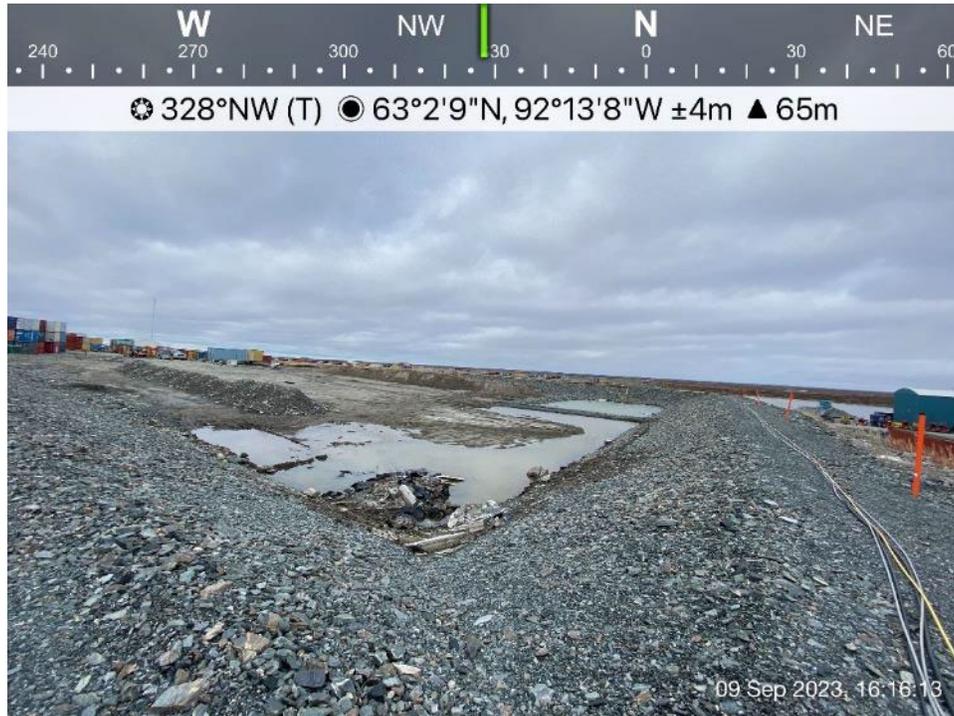
Landfarm - Photo 19: Landfarm - Overview of landfarm, looking northwest

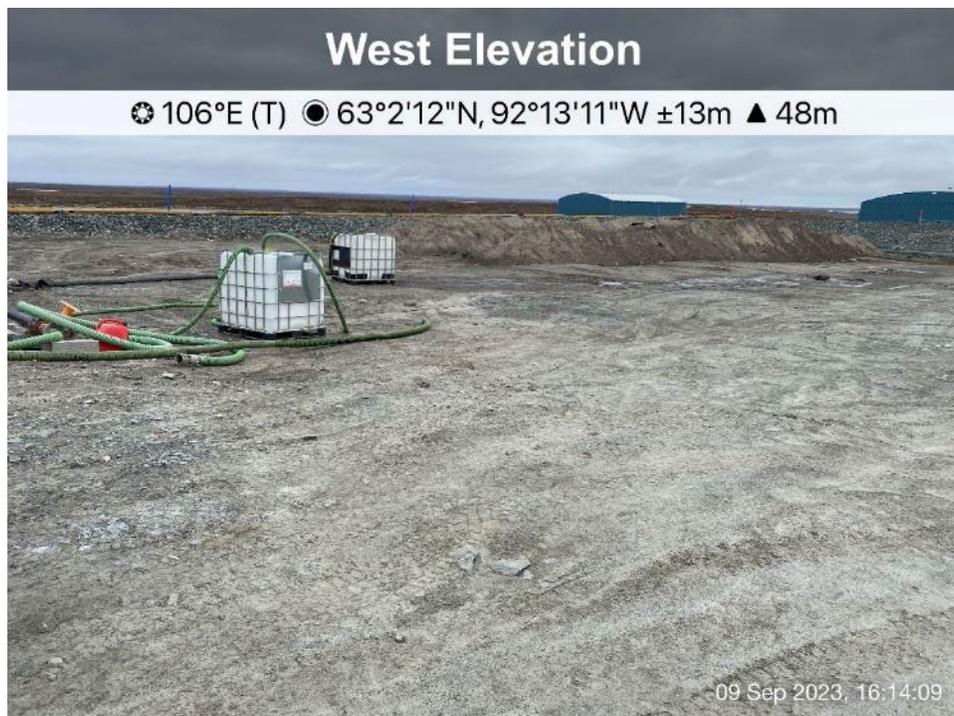
Landfarm - Photo 20: Landfarm - Contaminated soil -1

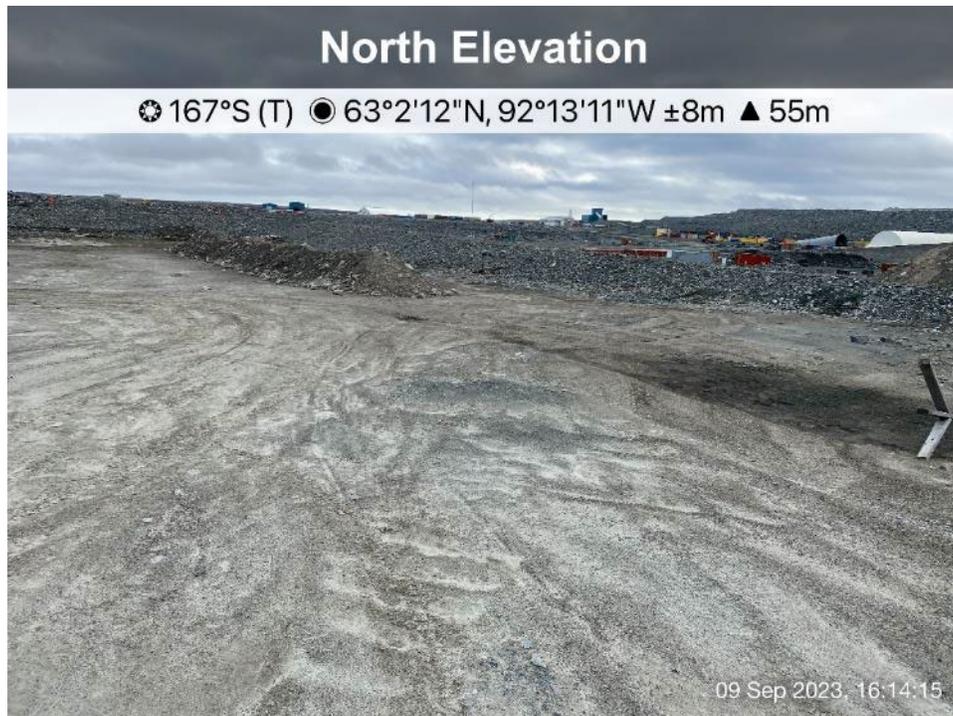
Landfarm - Photo 21: Landfarm - Contaminated soil -2

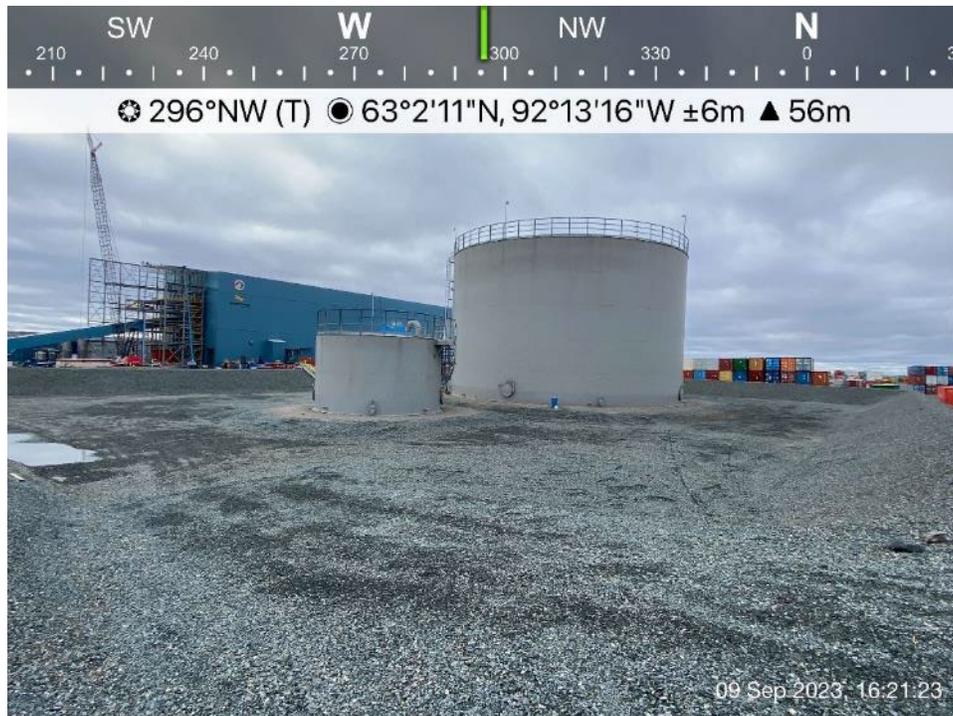
Industrial Fuel Tanks -Photo 23: Industrial Fuel Tanks - Overview, looking northwest.

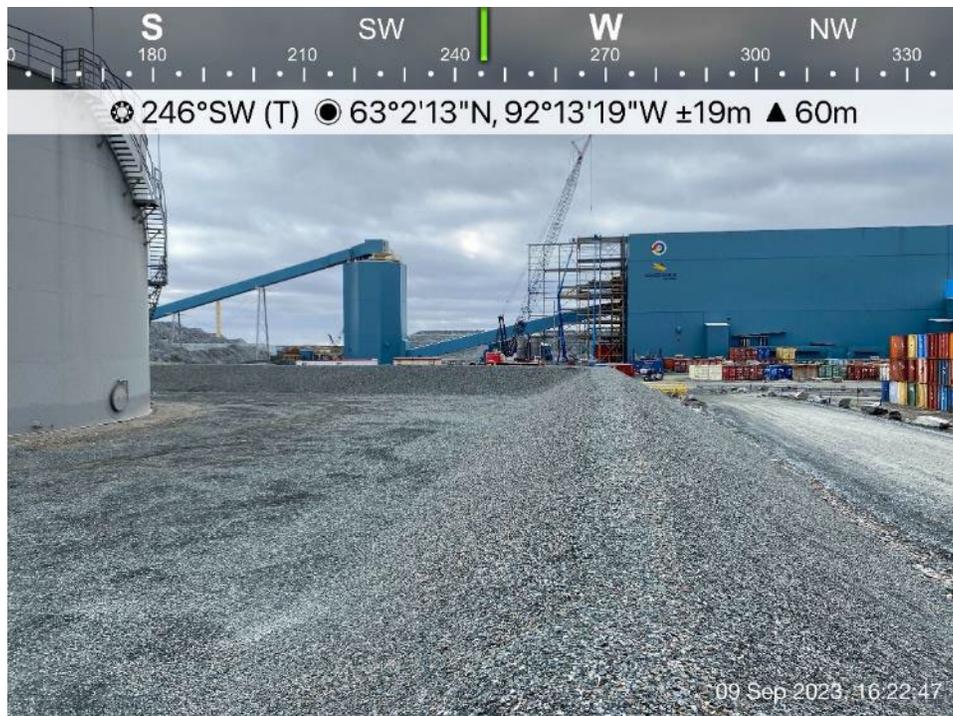
Industrial Fuel Tanks -Photo 24: Industrial Fuel Tanks - north side berm, looking southwest.

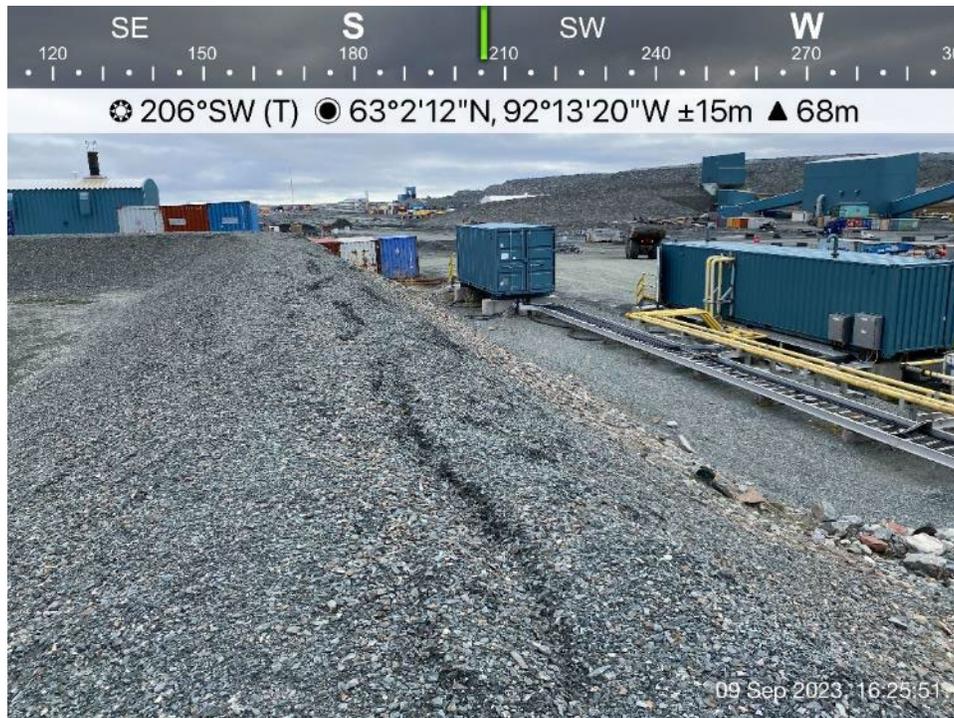
Industrial Fuel Tanks -Photo 25: Industrial Fuel Tanks - west side berm, looking southwest.

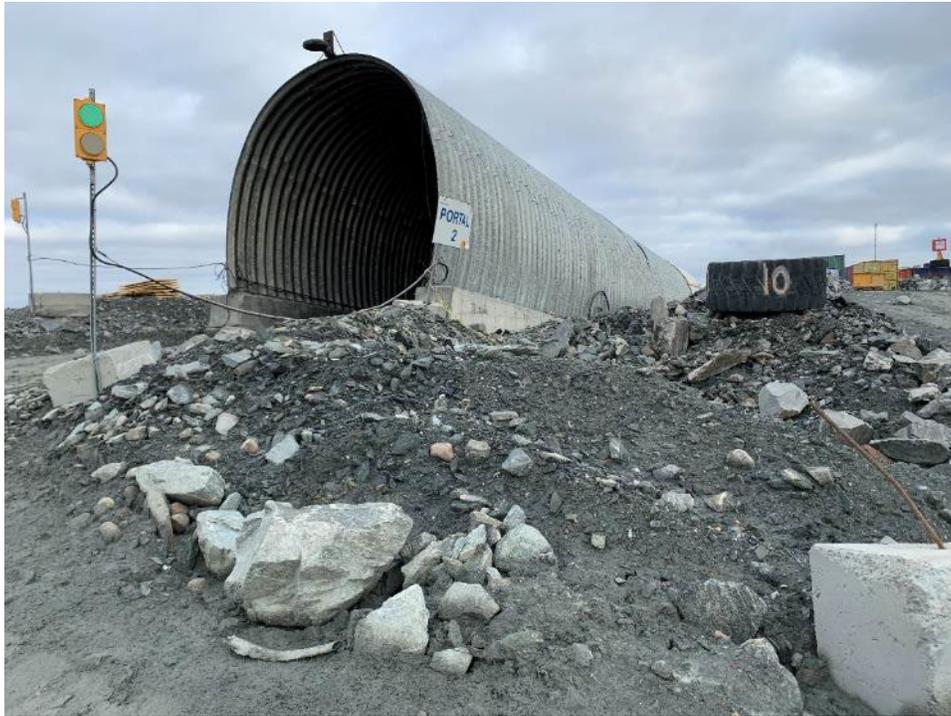
Portal 1 - Photo 28: Portal 1 – Overview.

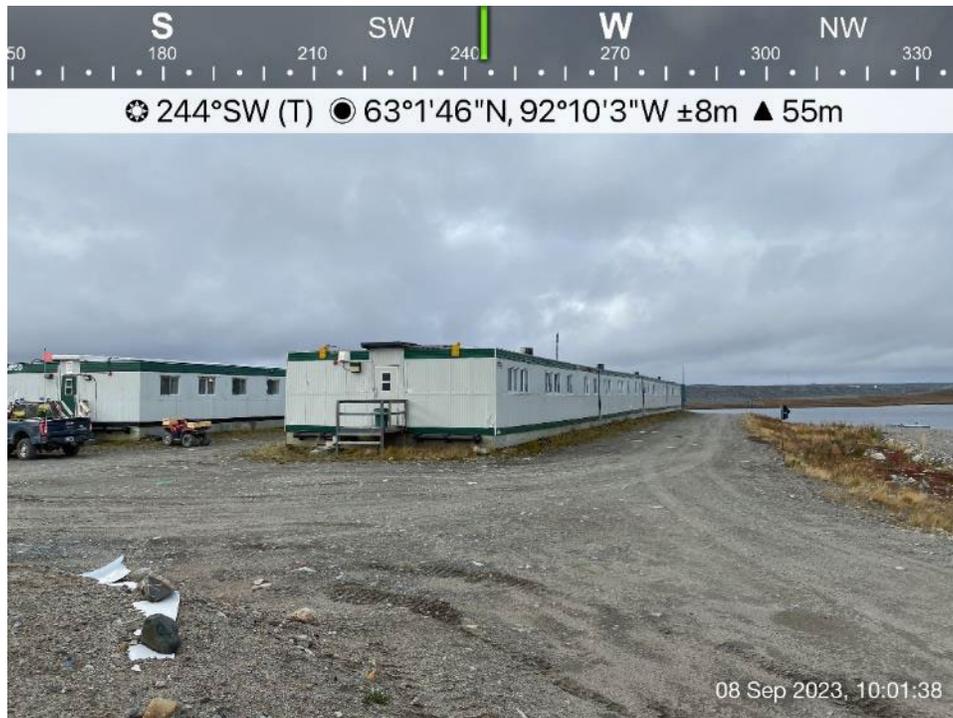
Exploration Camp - Photo 1: Exploration Camp - Overview, looking southwest.

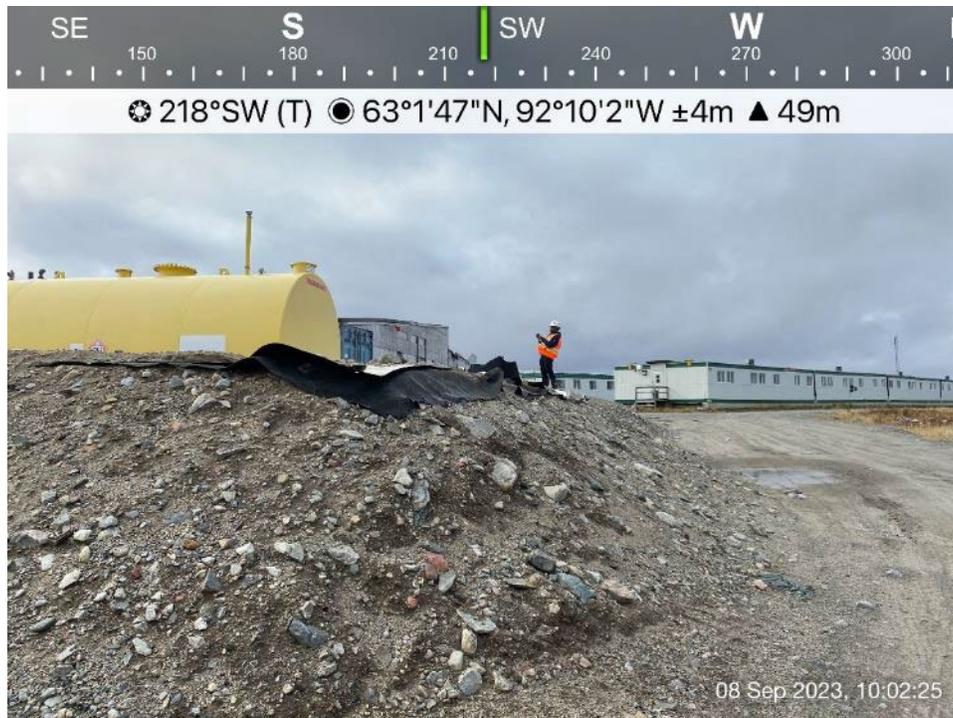
Exploration Camp - Photo 2: Exploration Camp - Fuel storage, looking southwest.

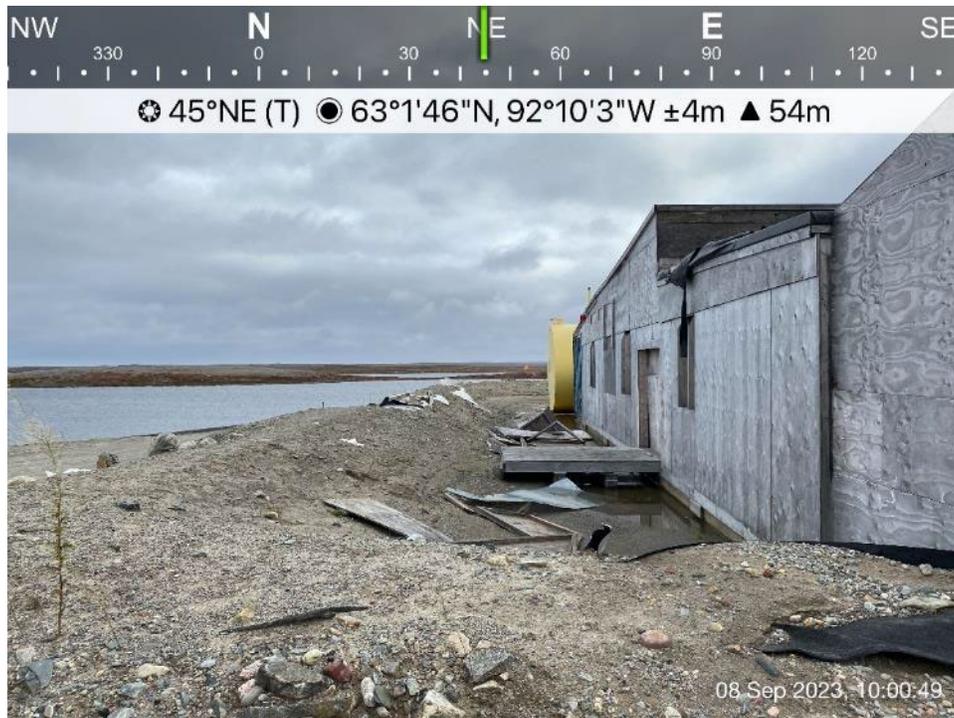
Exploration Camp - Photo 3: Exploration Camp - Fuel storage, looking northeast.

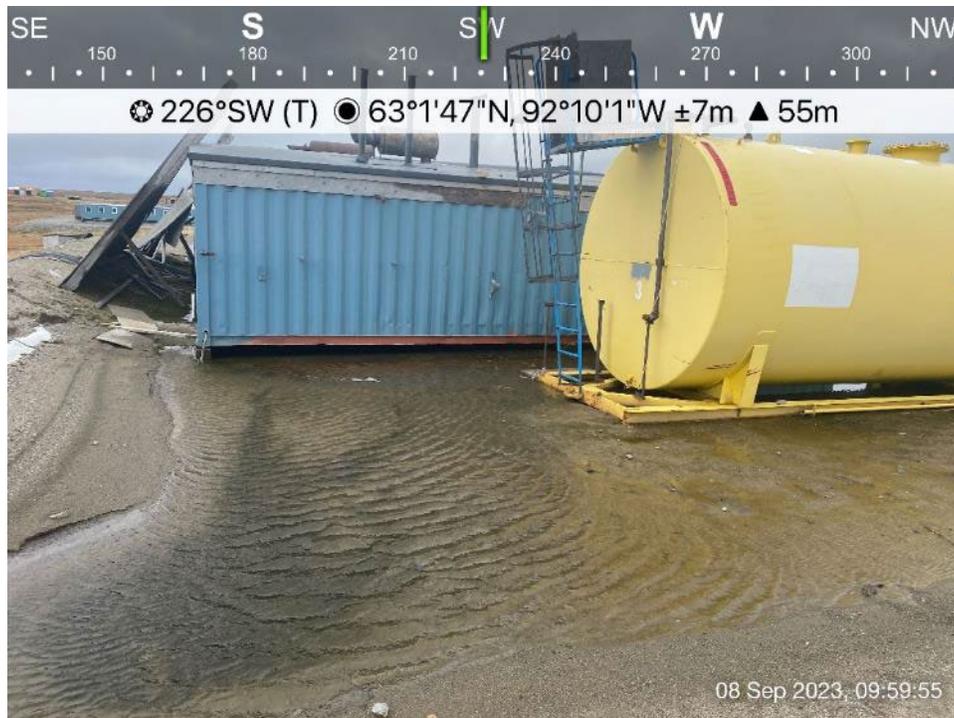
Exploration Camp - Photo 4: Exploration Camp - Fuel storage, looking southwest.

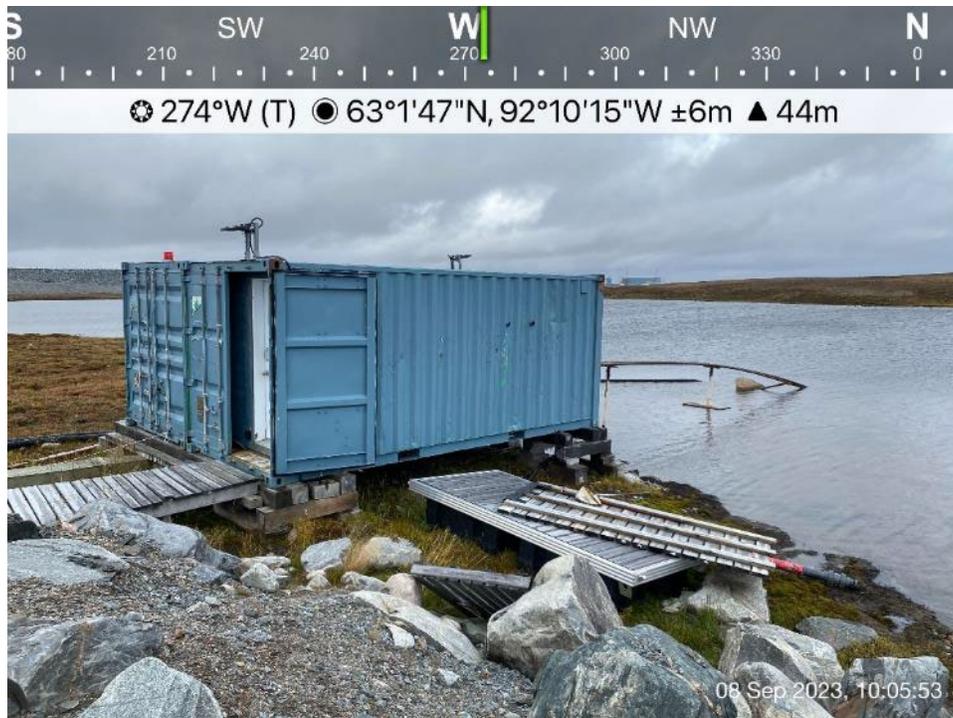
Exploration Camp - Photo 6: Exploration Camp - freshwater intake pump house, looking west.

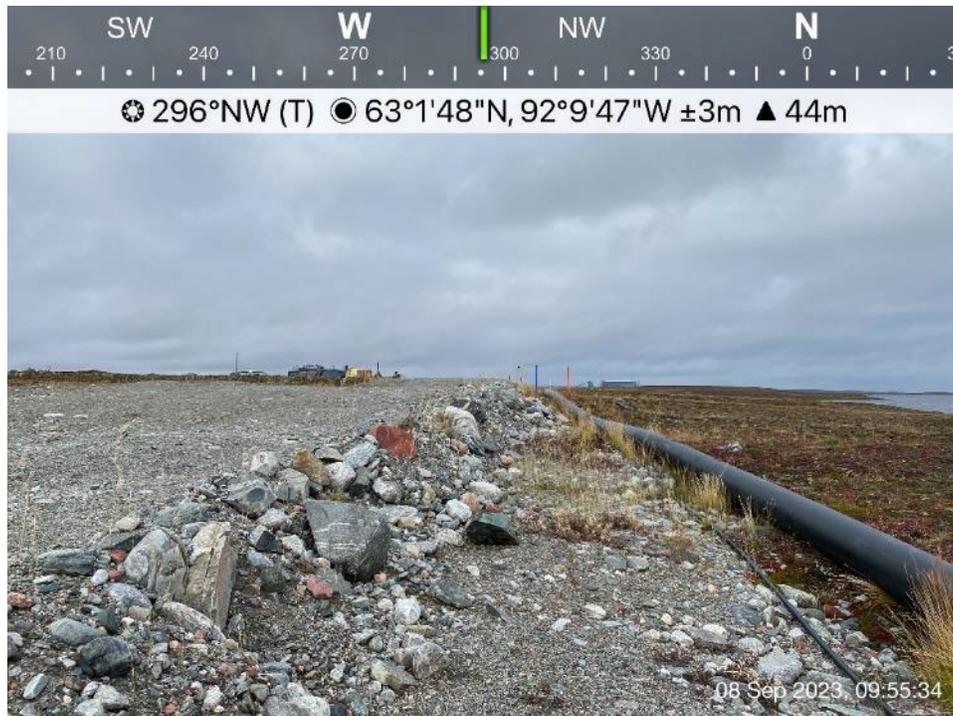
Exploration Camp - Photo 7: Exploration Camp - diffuser access road, looking northwest.

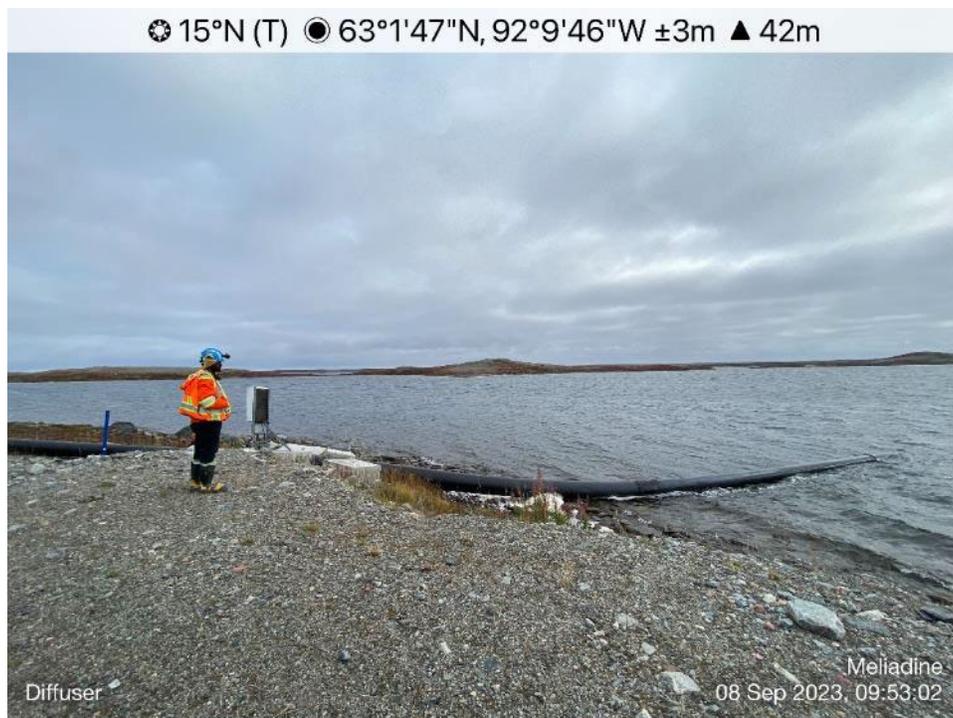
Exploration Camp - Photo 8: Exploration Camp - diffuser pipeline, looking north.

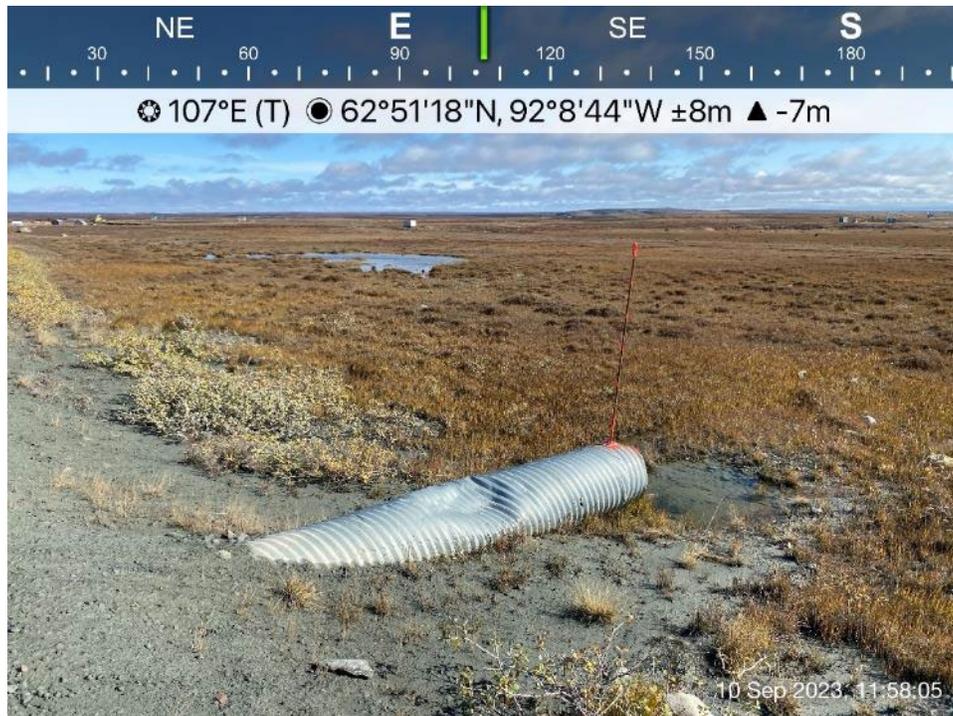
AWAR Road/Culvert - Photo 1: Culvert KM 5.5 - inlet.

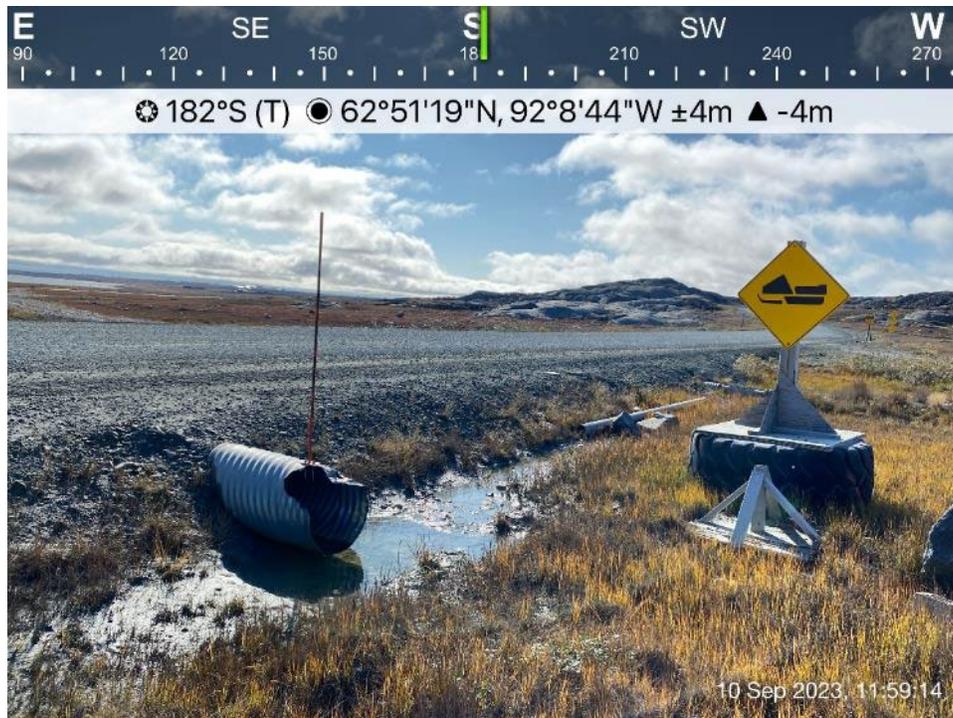
AWAR Road/Culvert - Photo 2: Culvert KM 5.5 - outlet.

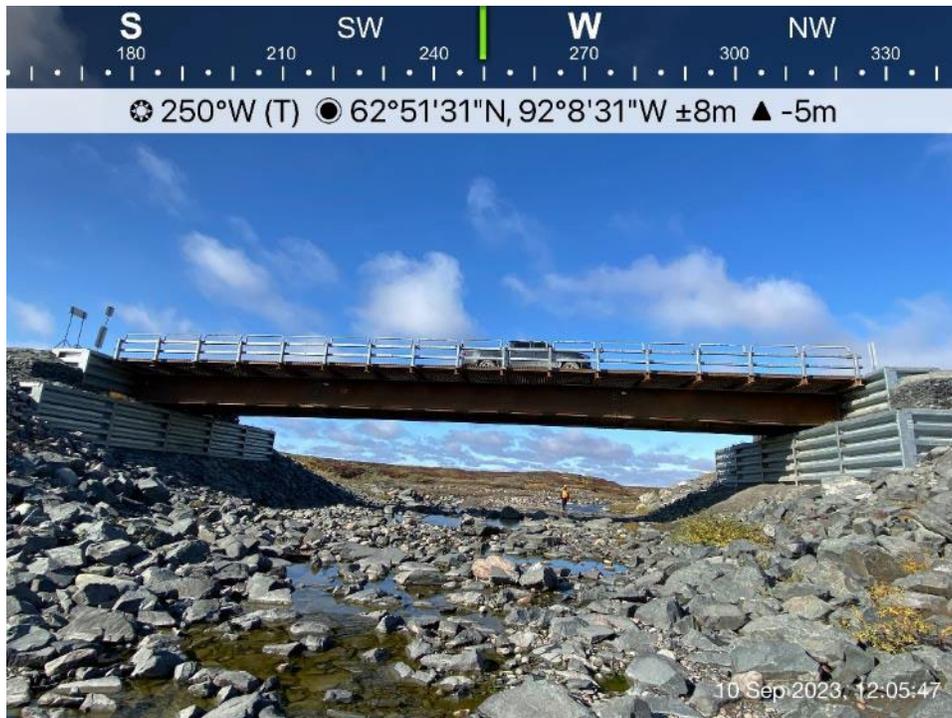
AWAR Road/Culvert - Photo 3: Char River Bridge KM 6.0.

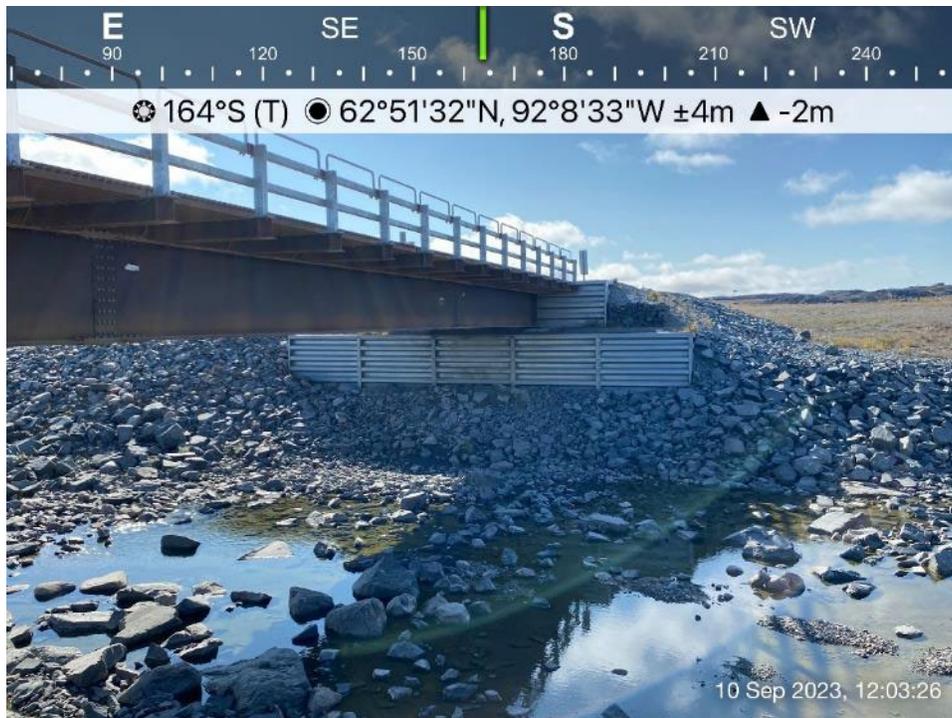
AWAR Road/Culvert - Photo 4: Char River Bridge KM 6.1 - north abutment.

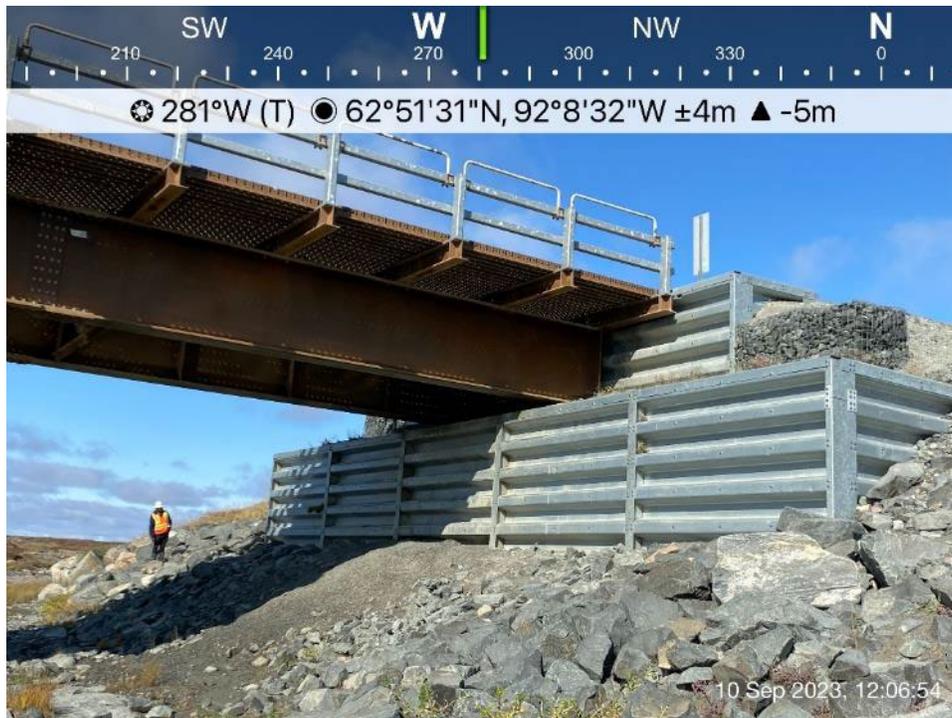
AWAR Road/Culvert - Photo 5: Char River Bridge KM 6.1 - south abutment.

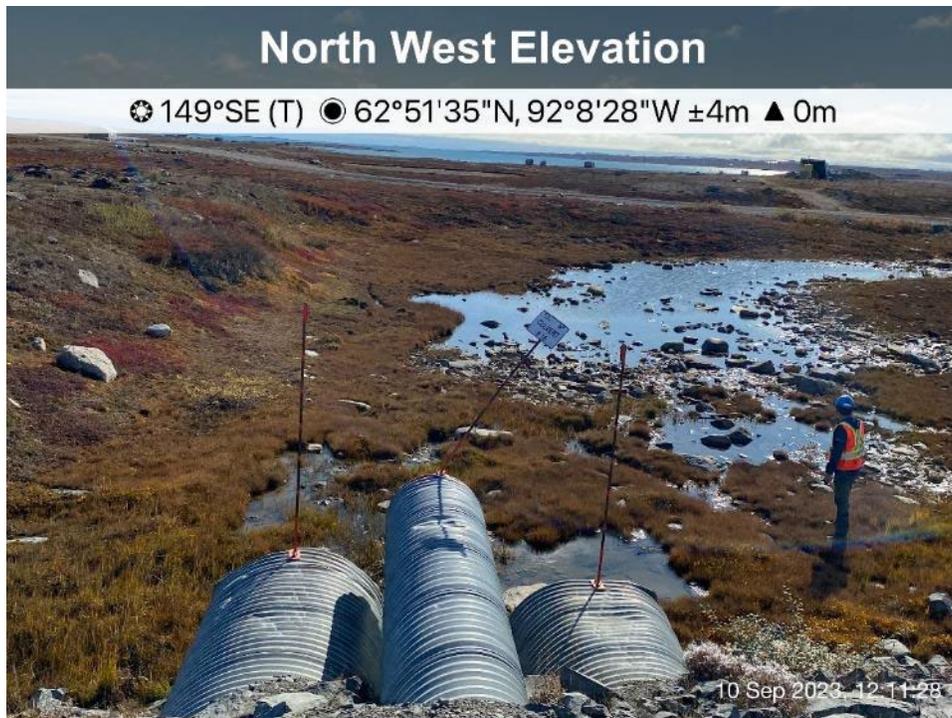
AWAR Road/Culvert - Photo 6: Culvert KM 6.2 - inlet.

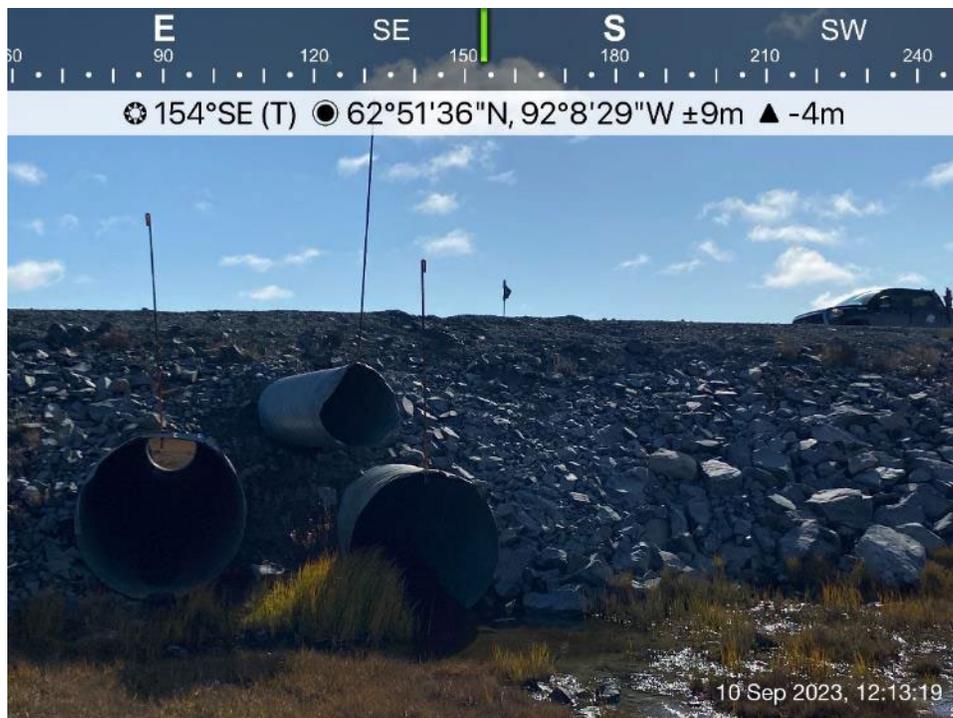
AWAR Road/Culvert - Photo 8: Culvert KM 6.2 - outlet.

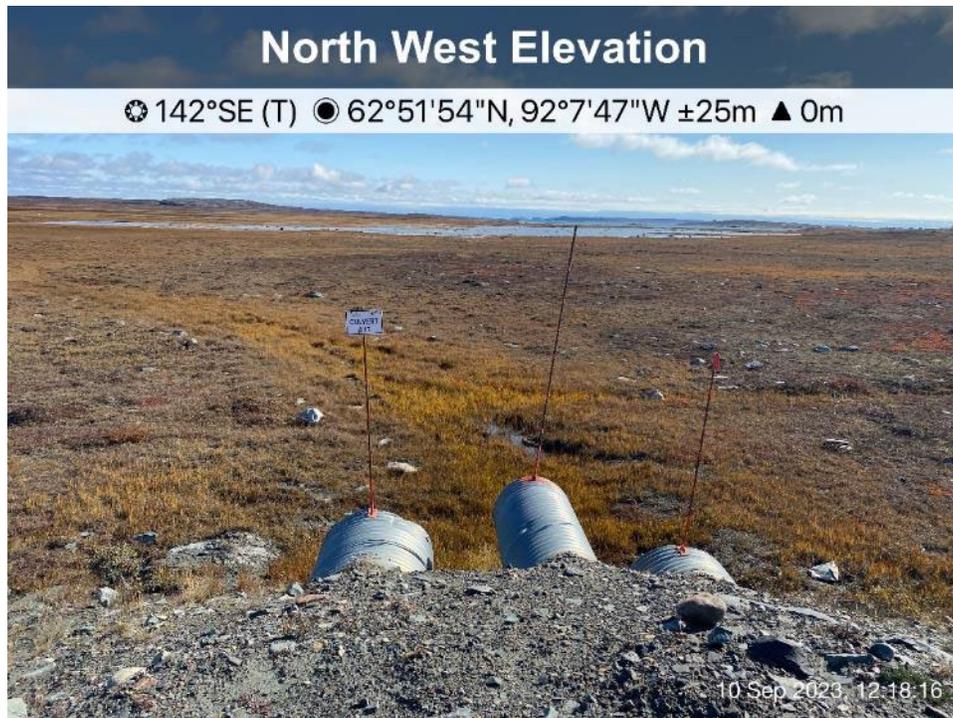
AWAR Road/Culvert - Photo 9: Culvert KM 7.0 - inlet.

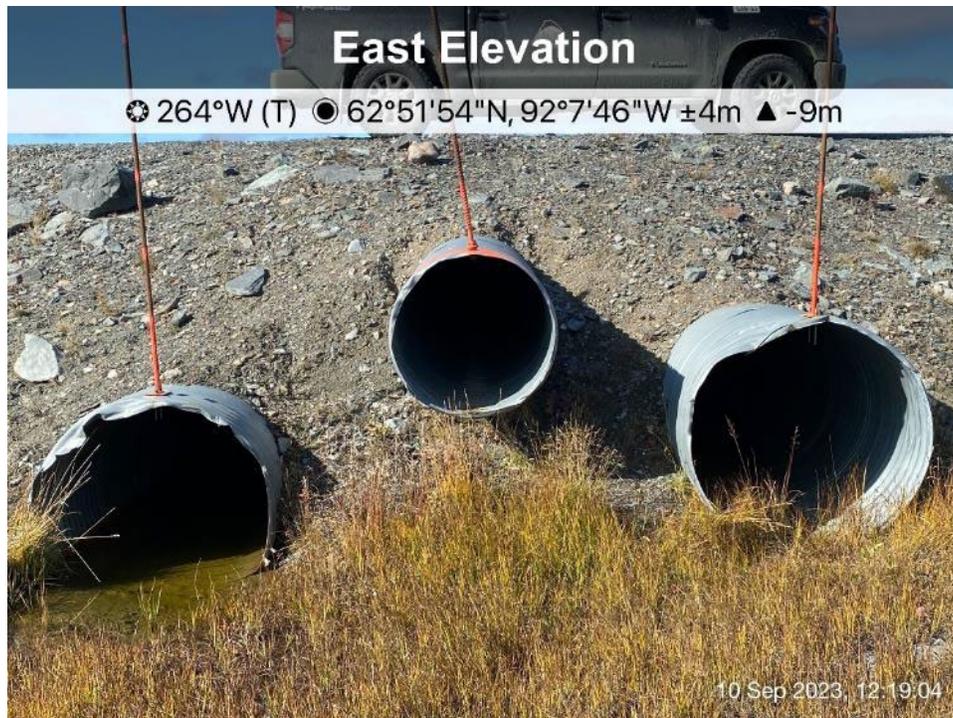
AWAR Road/Culvert - Photo 10: Culvert KM 7.0 - inlet.

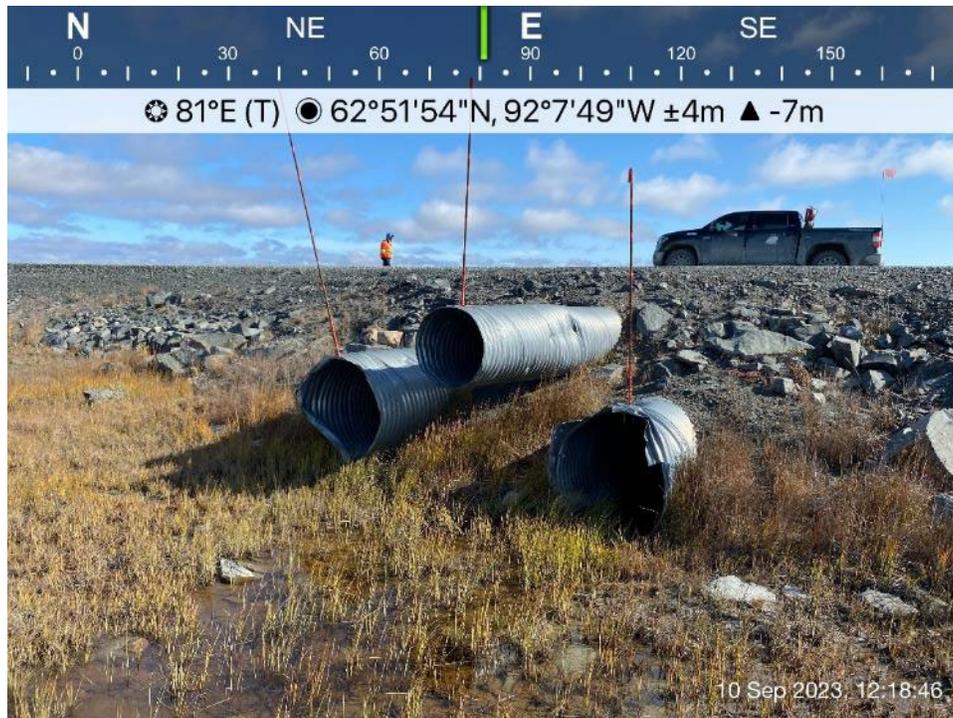
AWAR Road/Culvert - Photo 11: Culvert KM 7.0 - outlet.

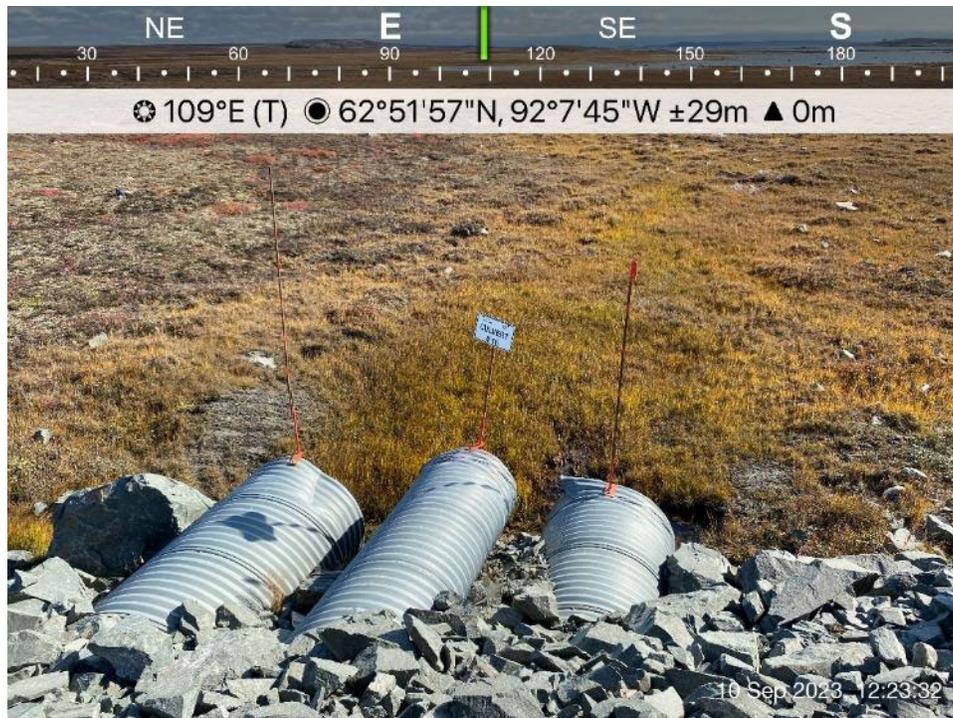
AWAR Road/Culvert - Photo 12: Culvert KM 7.1 - inlet.

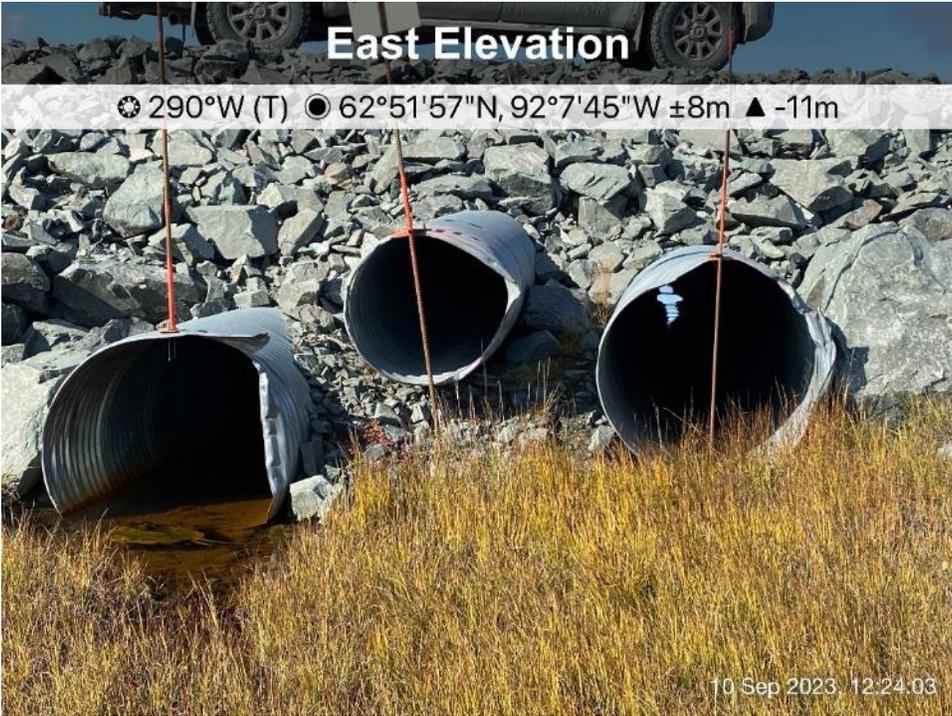
AWAR Road/Culvert - Photo 13: Culvert KM 7.1 – inlet.

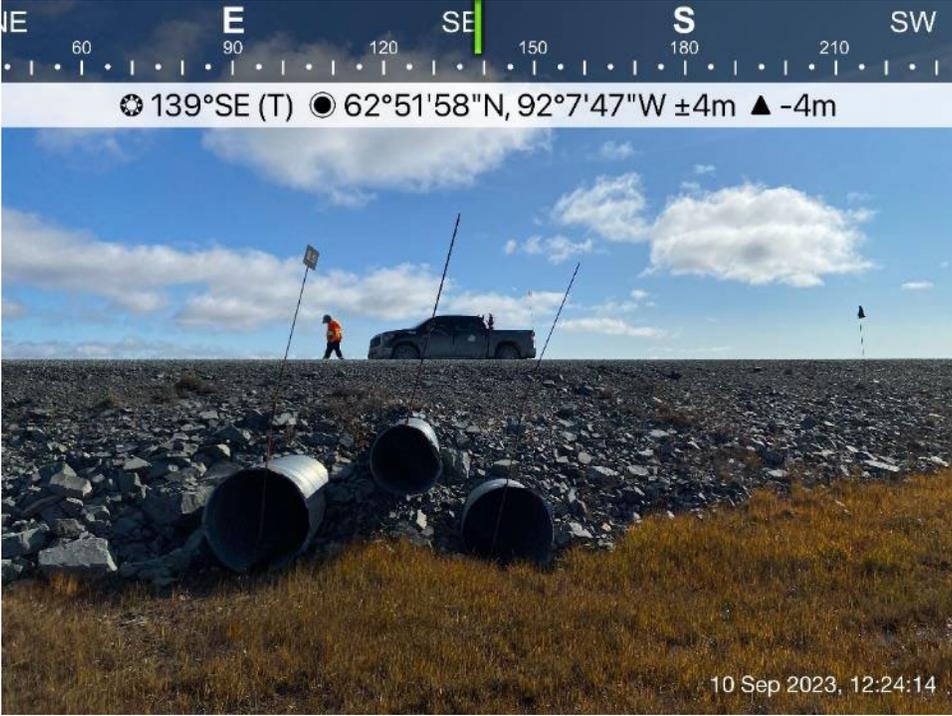
AWAR Road/Culvert - Photo 14: Culvert KM 7.1 – outlet.

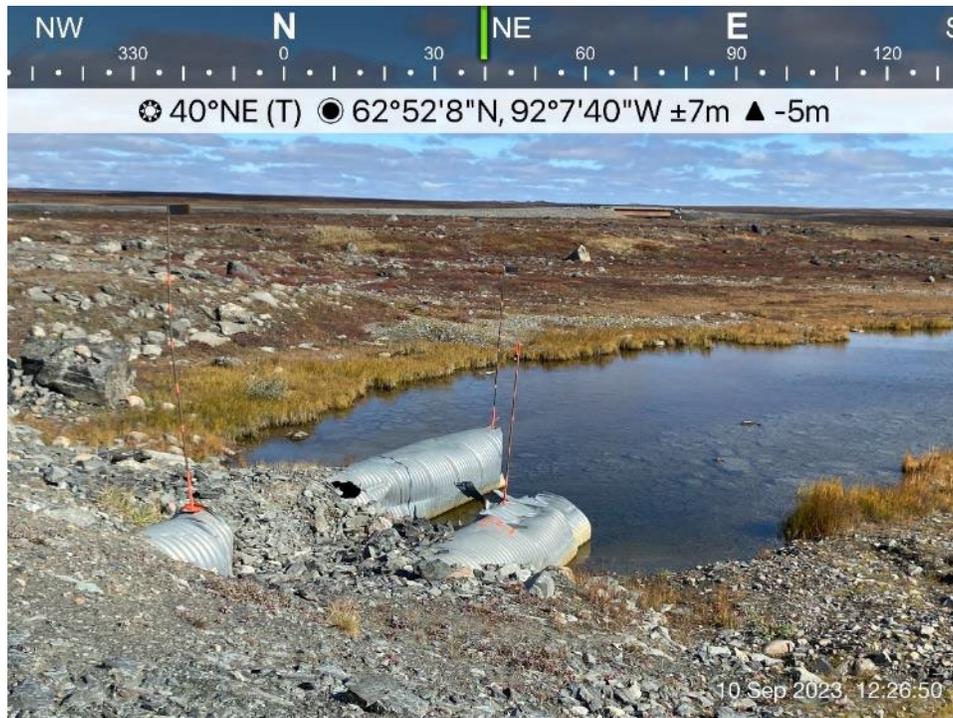
AWAR Road/Culvert - Photo 15: Culvert KM 7.4 – inlet.

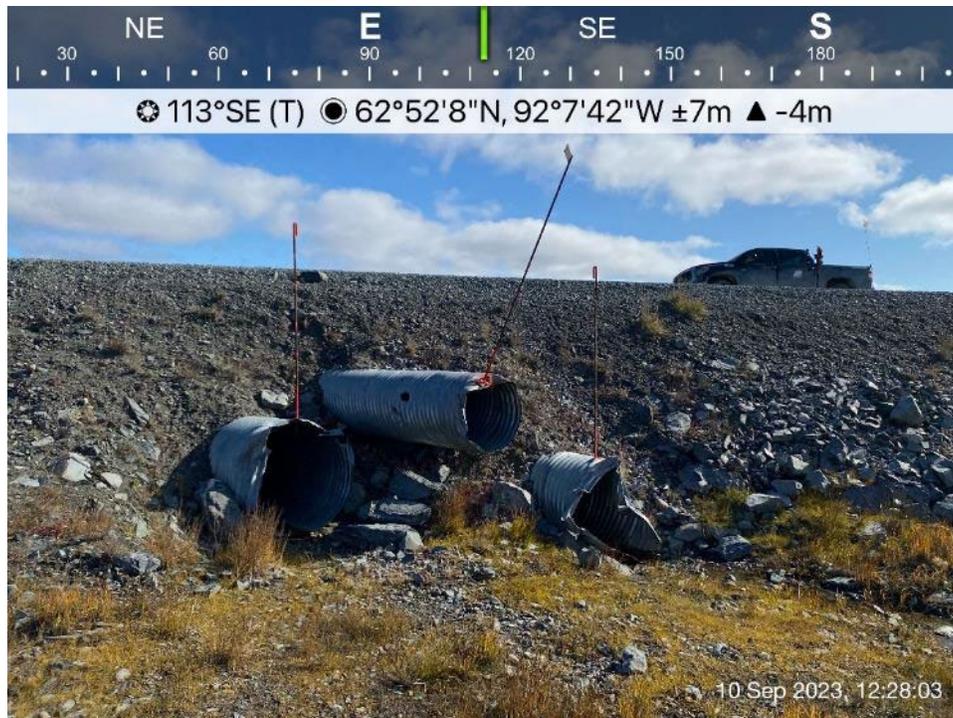
AWAR Road/Culvert - Photo 16: Culvert KM 7.4 – outlet.

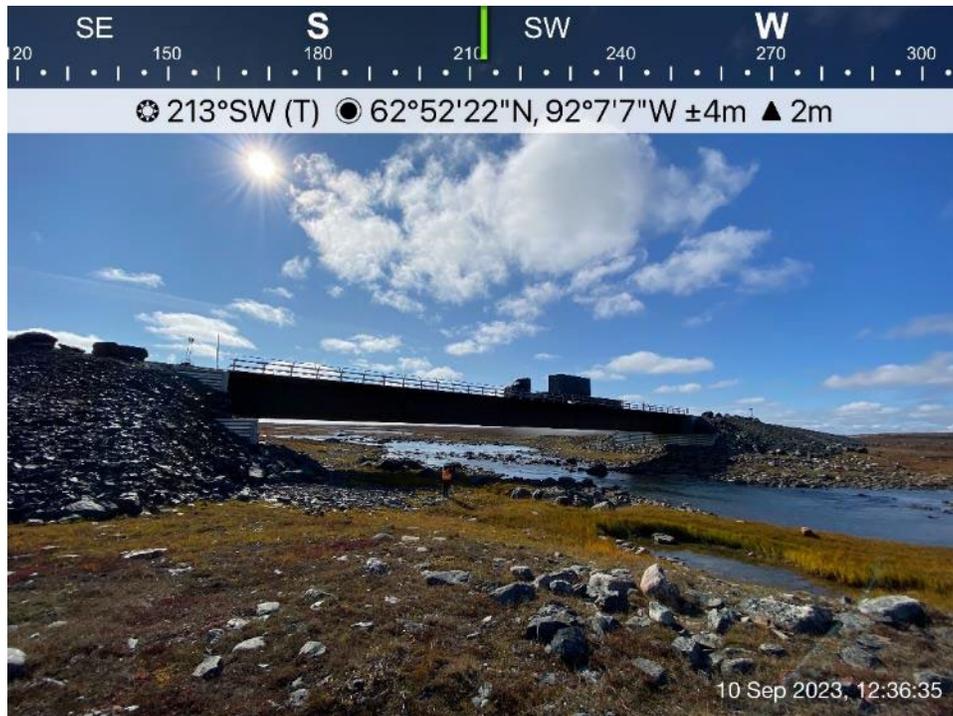
AWAR Road/Culvert - Photo 17: Meliadine River Bridge KM 8.0.
