ALL-WEATHER ACCESS ROAD (AWAR)

APPENDIX S

ITIVIA FUEL STORAGE AND BYPASS ROAD

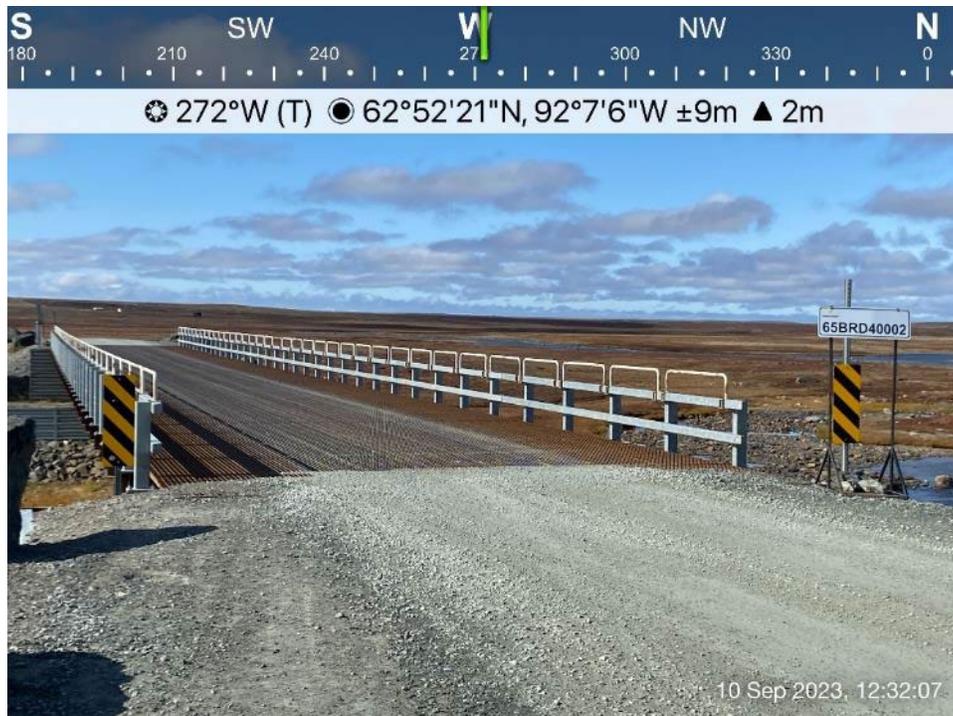
AWAR Road/Culvert - Photo 18: Meliadine River Bridge KM 8.0.

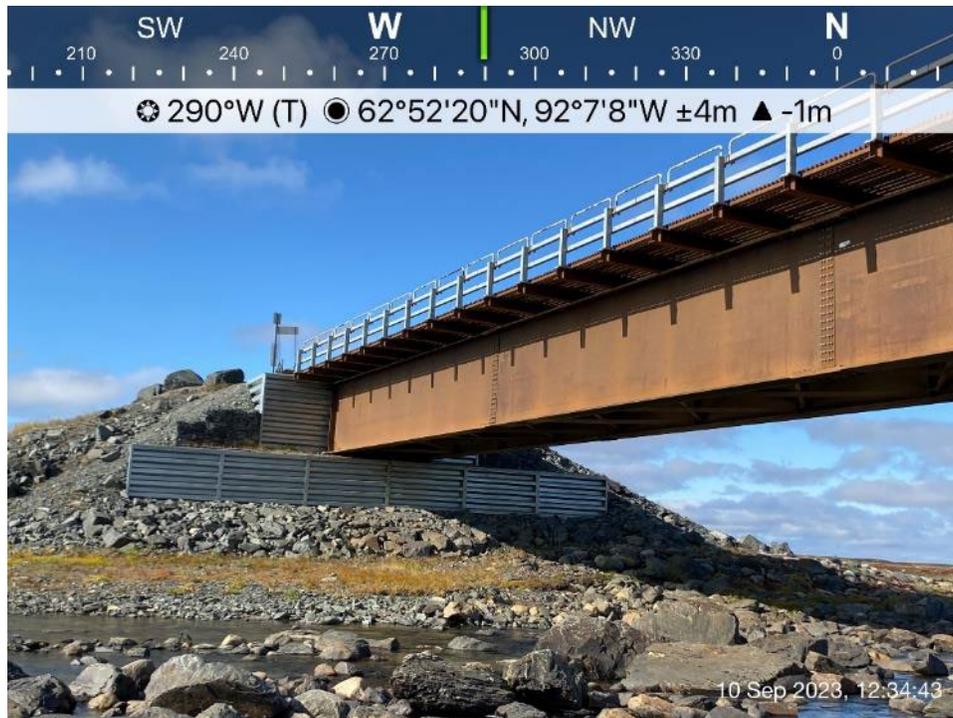
AWAR Road/Culvert - Photo 19: Meliadine River Bridge KM 8.0- east abutment.

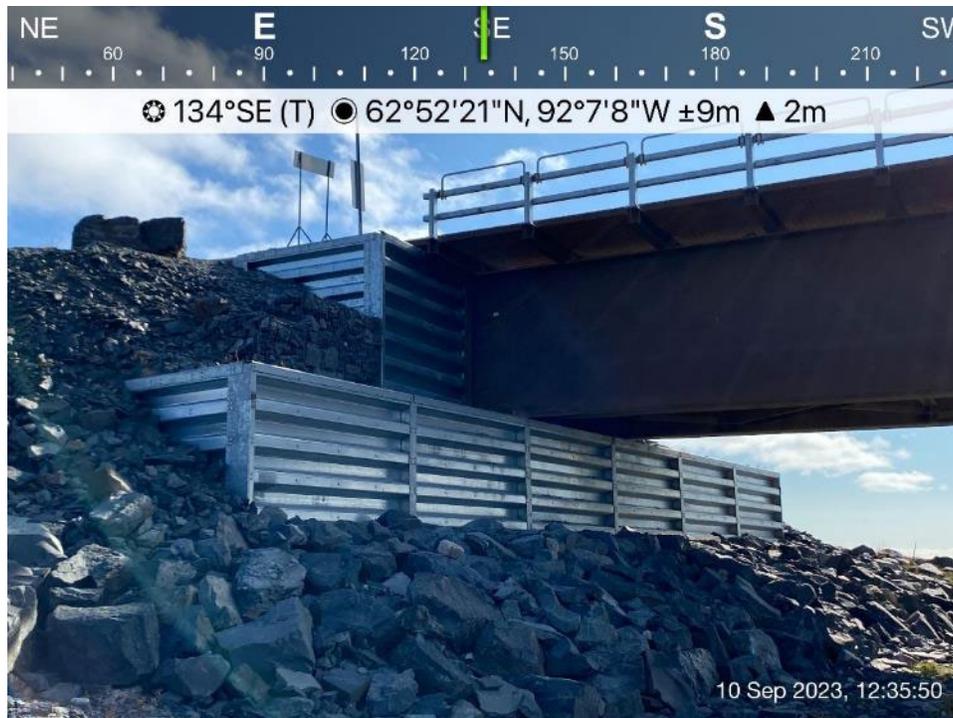
AWAR Road/Culvert - Photo 20: Meliadine River Bridge KM 8.0- west abutment.

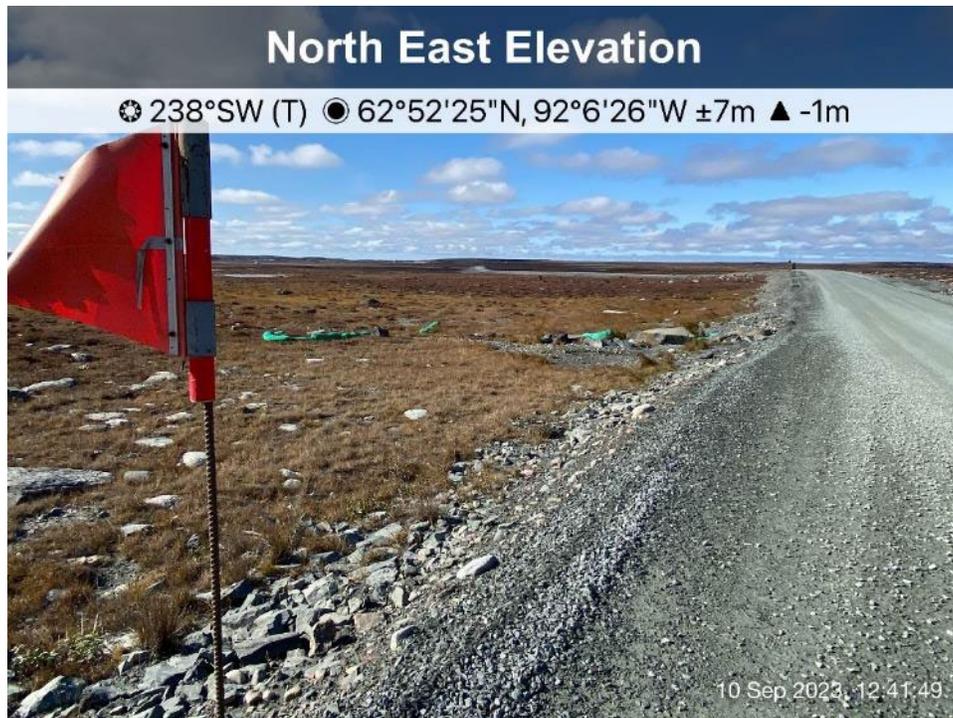
AWAR Road/Culvert - Photo 21: KM 8.8 - No culvert installed, water overflows the road during freshet.

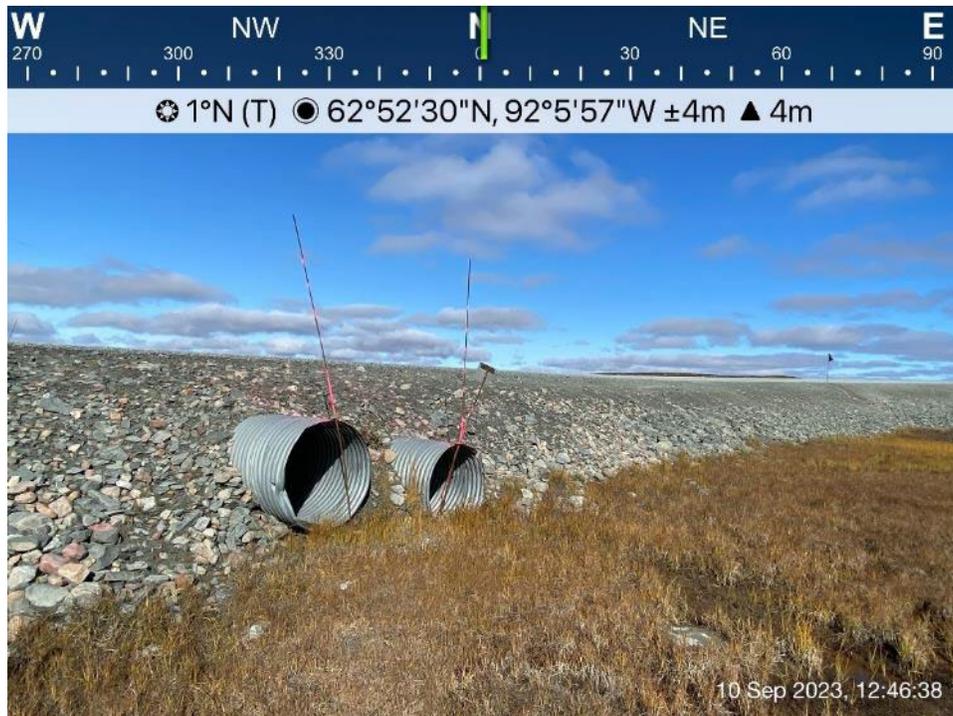
AWAR Road/Culvert - Photo 23: Culvert KM 9.1 – inlet.

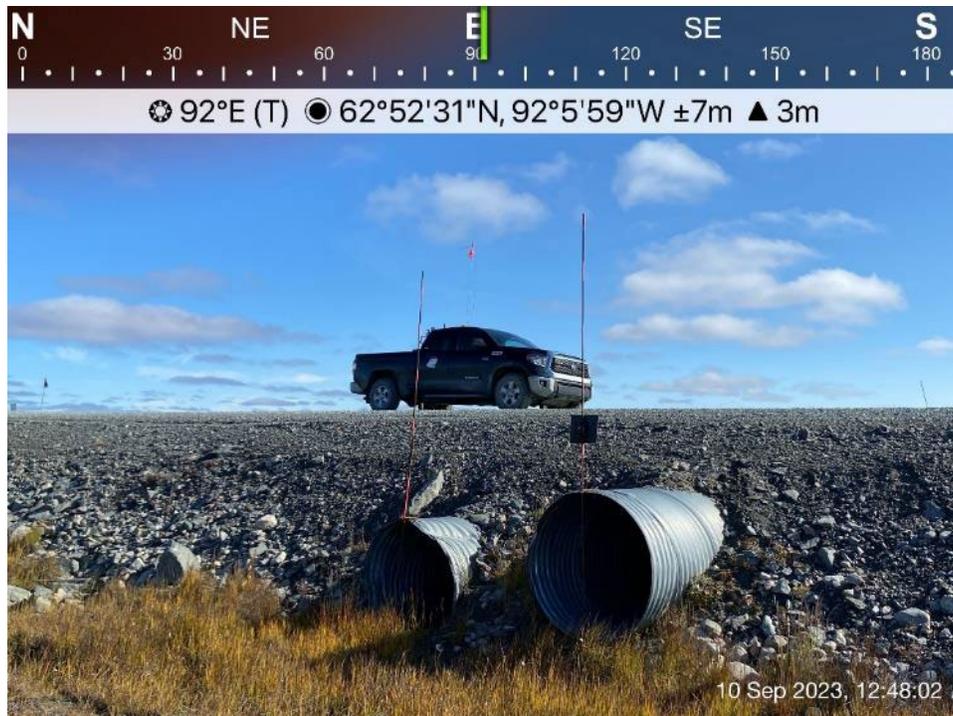
AWAR Road/Culvert - Photo 24: Culvert KM 9.1 – outlet.

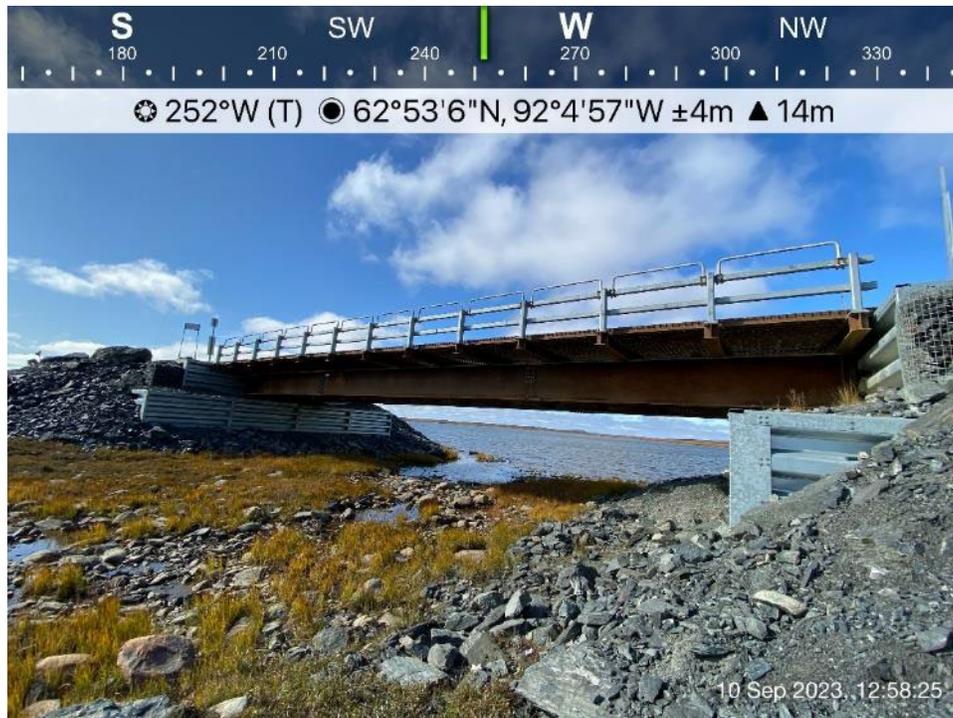
AWAR Road/Culvert - Photo 27: M-5 Bridge KM 10.5.

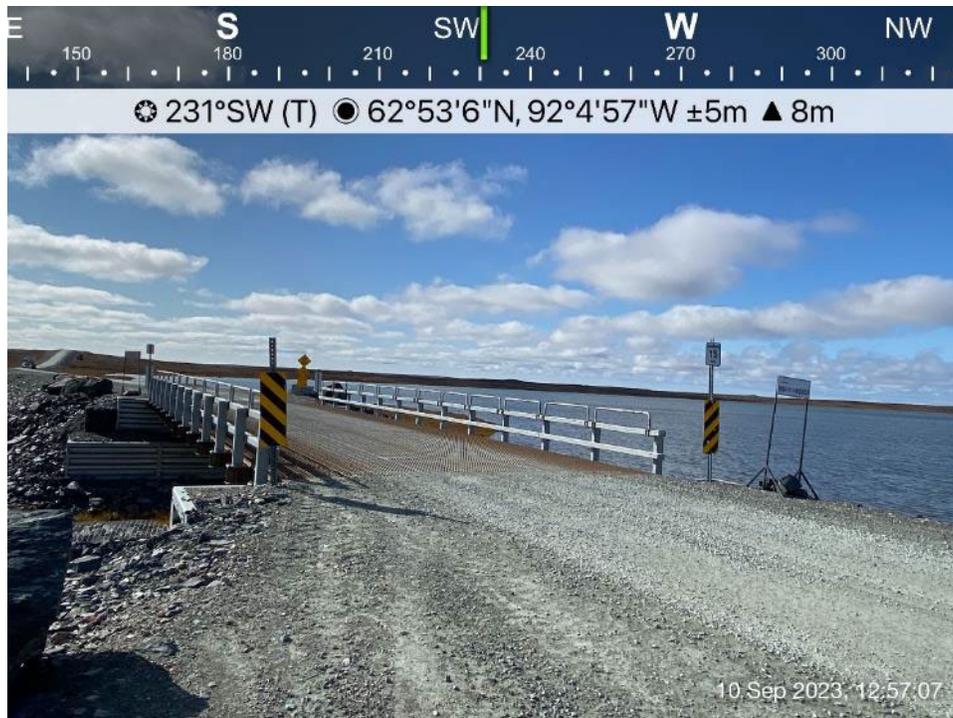
AWAR Road/Culvert - Photo 28: M-5 Bridge KM 10.5.

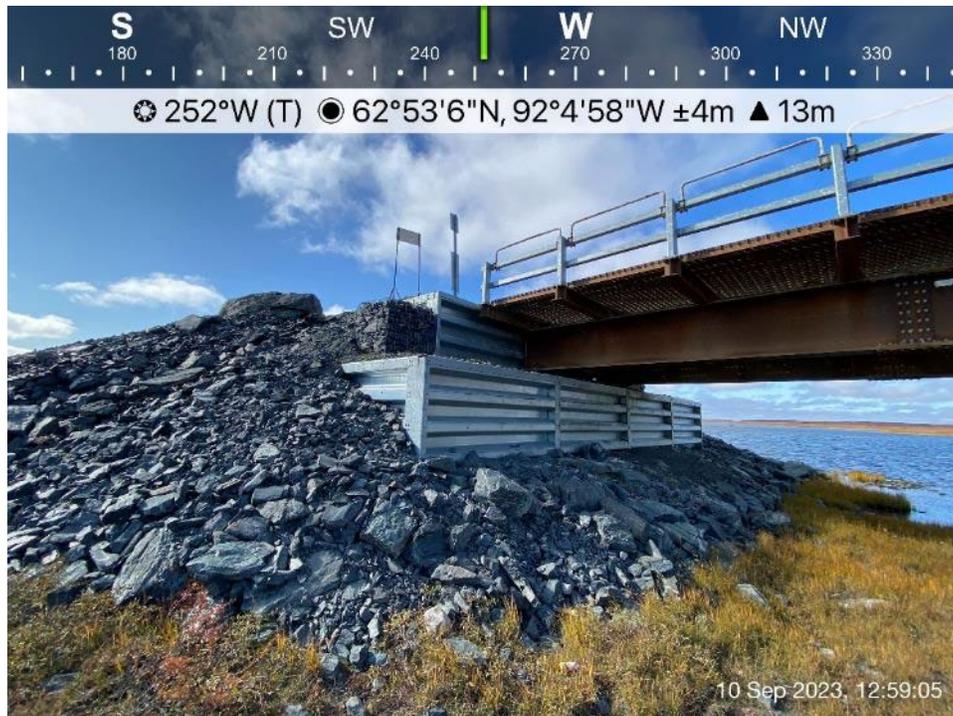
AWAR Road/Culvert - Photo 29: M-5 Bridge KM 10.5- south abutment.

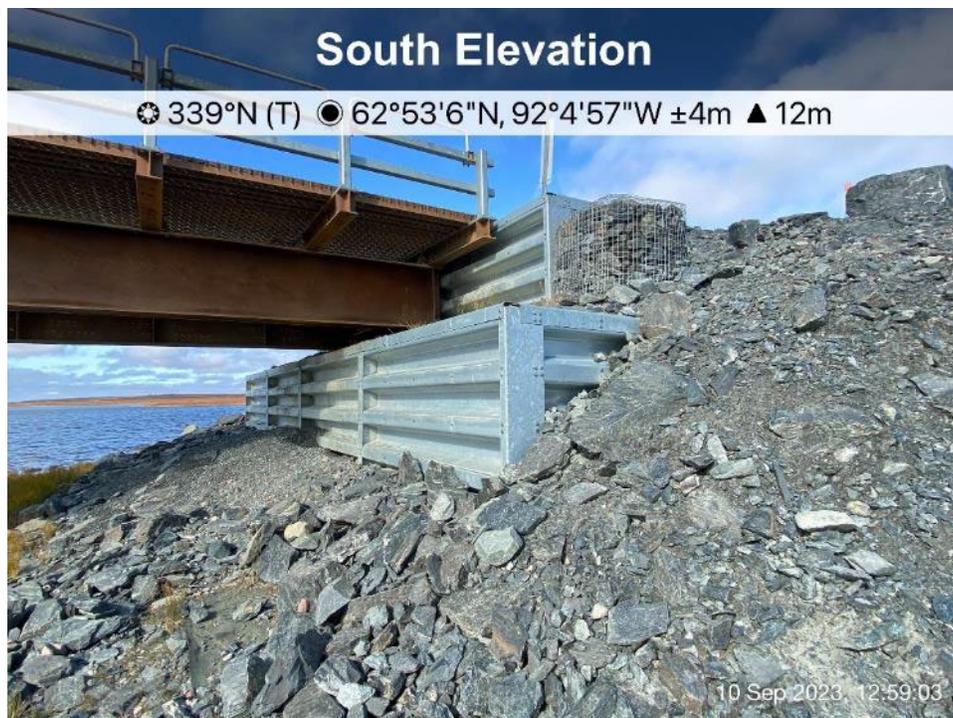
AWAR Road/Culvert - Photo 30: M-5 Bridge KM 10.5- north abutment.

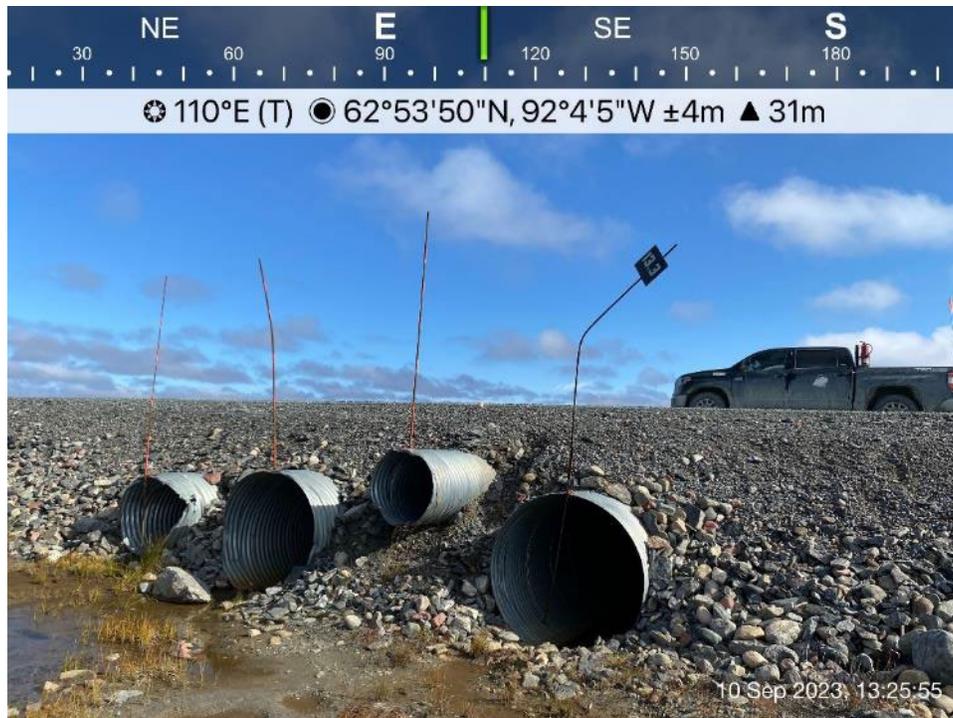
AWAR Road/Culvert - Photo 32: Culvert KM 12.1 – outlet.

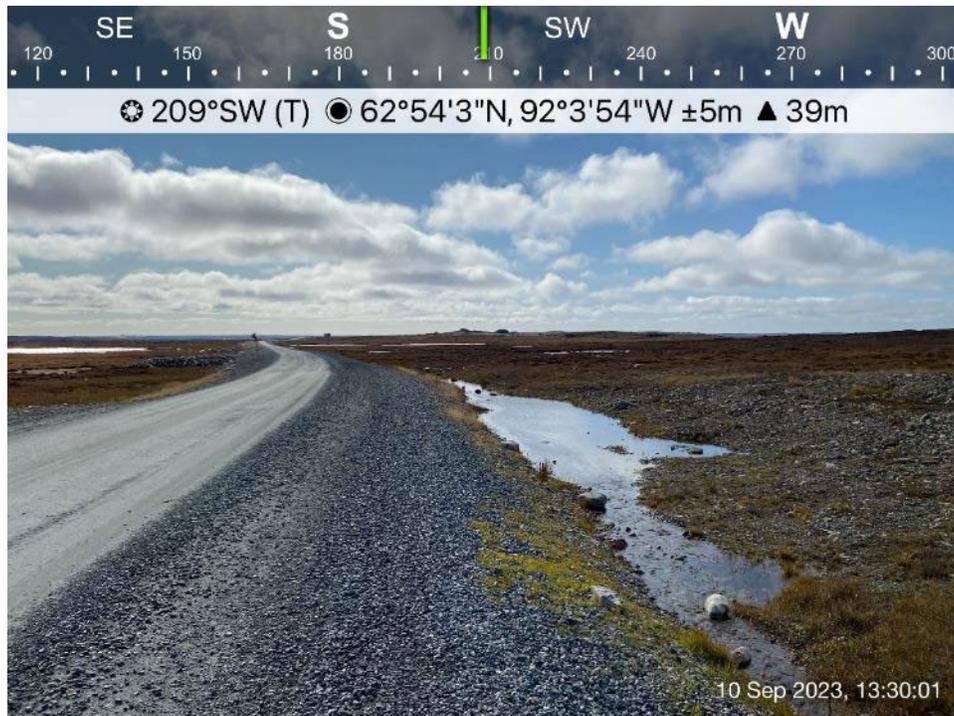
AWAR Road/Culvert - Photo 33: KM 12.6 - No culvert installed, poor drainage condition, no sign of water flow.

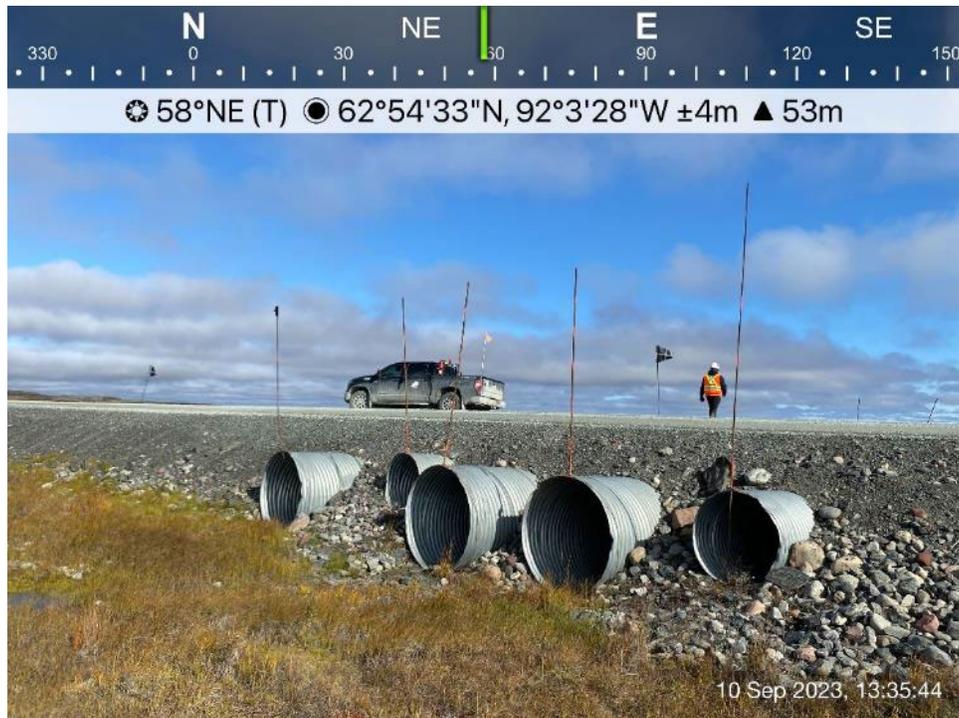
AWAR Road/Culvert - Photo 37: Culvert KM 13.5 – outlet.

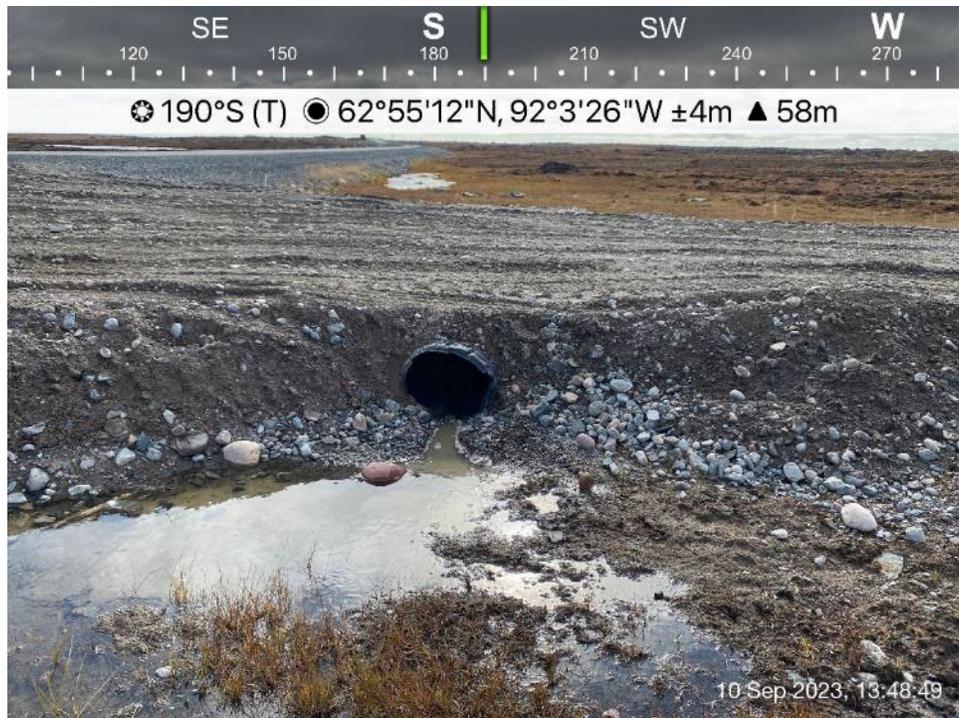
AWAR Road/Culvert - Photo 38: Culvert KM 14.7 - inlet - HDPE corrugated culvert.

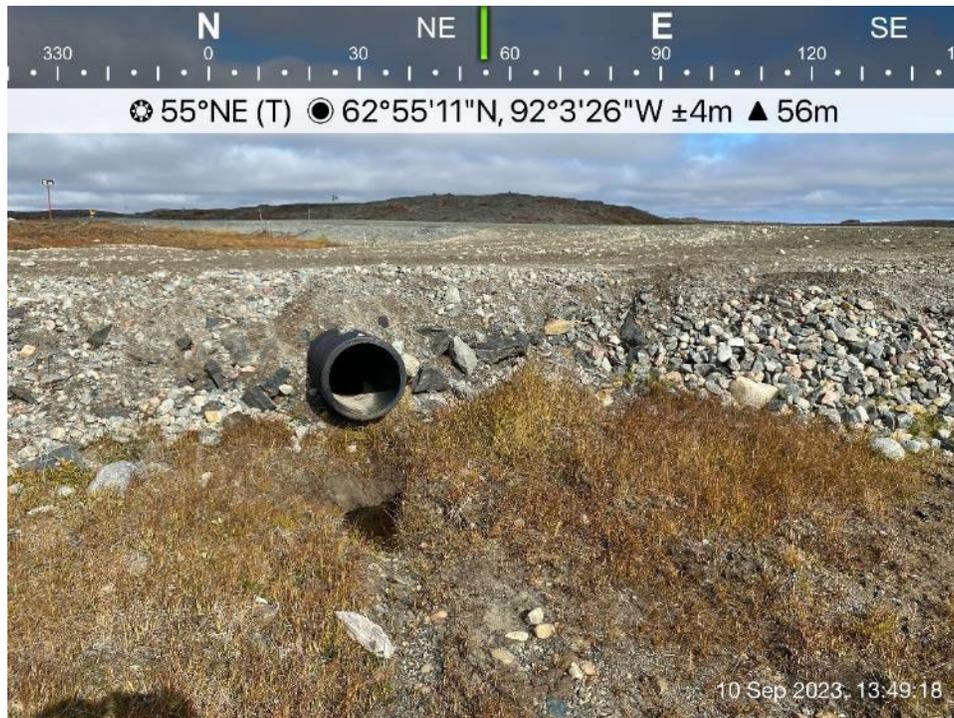
AWAR Road/Culvert - Photo 39: Culvert KM 14.7 - outlet- HDPE corrugated culvert.

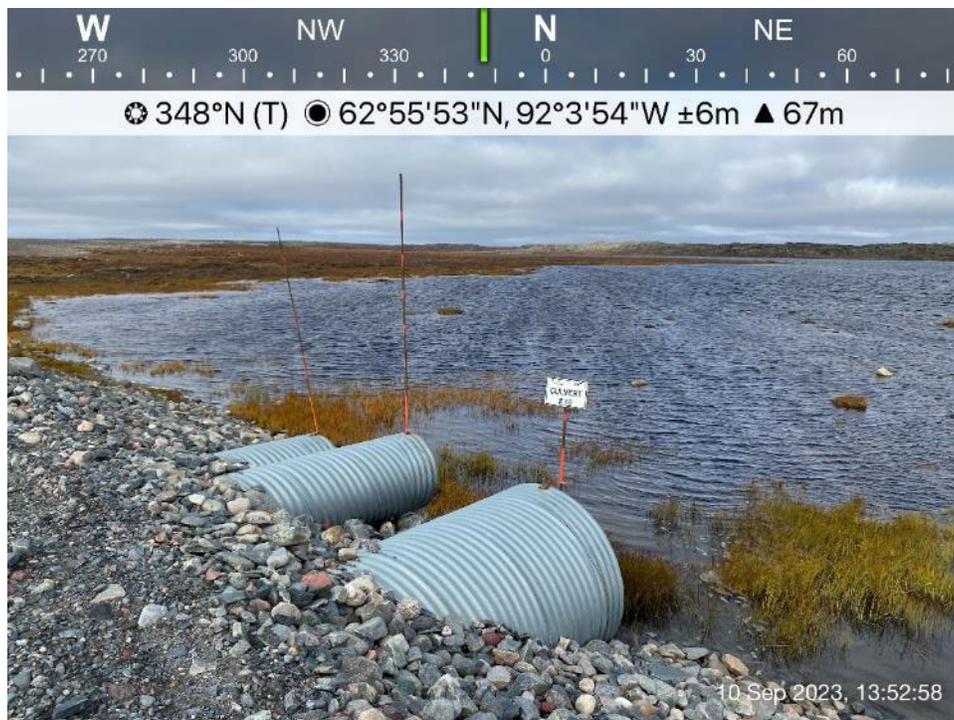
AWAR Road/Culvert - Photo 40: Culvert KM 16.3 – inlet.

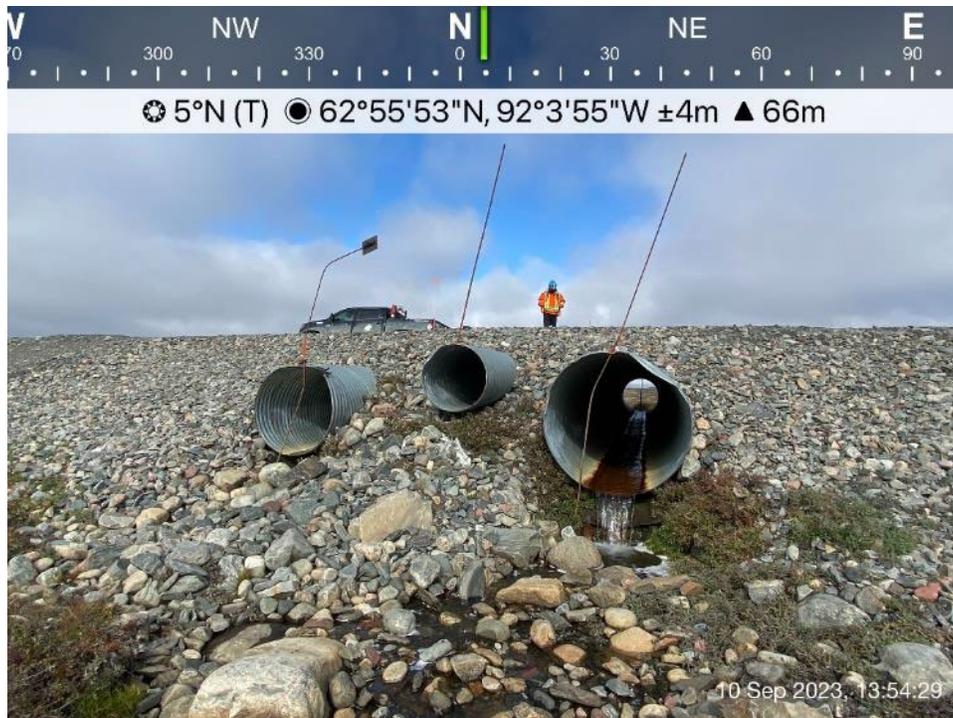
AWAR Road/Culvert - Photo 42: Culvert KM 16.3 – outlet.

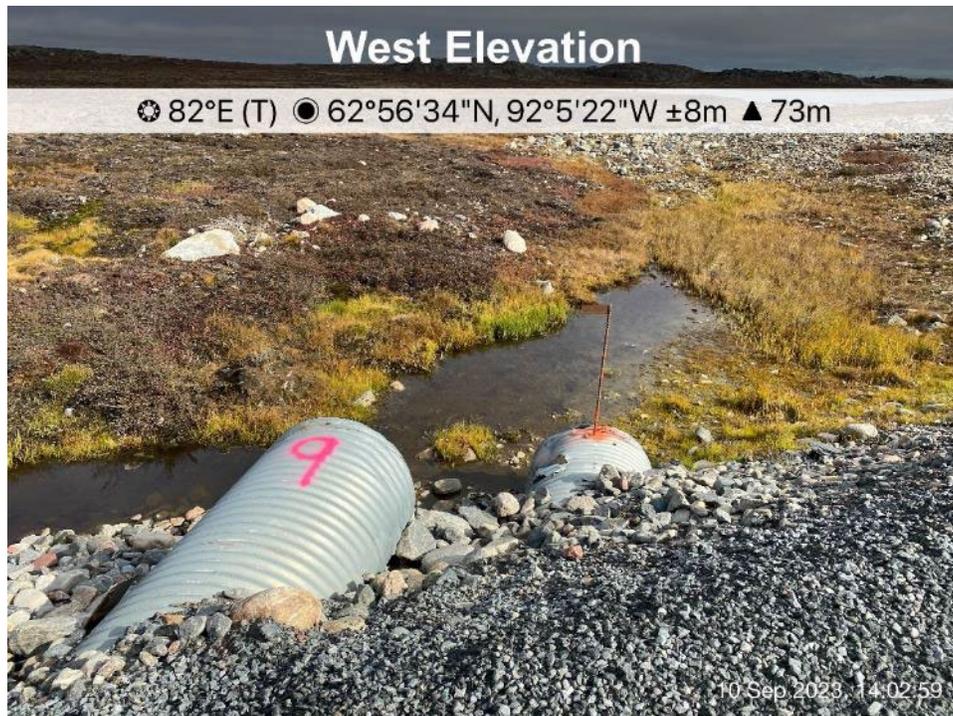
AWAR Road/Culvert - Photo 43: Culvert KM 18.1 – inlet.

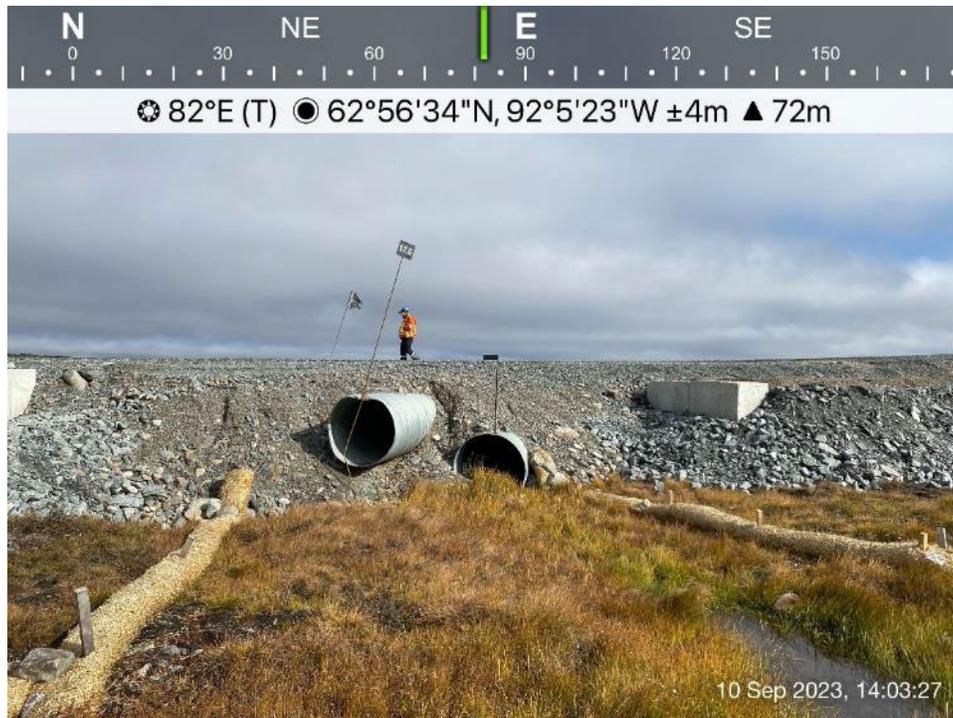
AWAR Road/Culvert - Photo 45: Culvert KM 18.1- outlet.

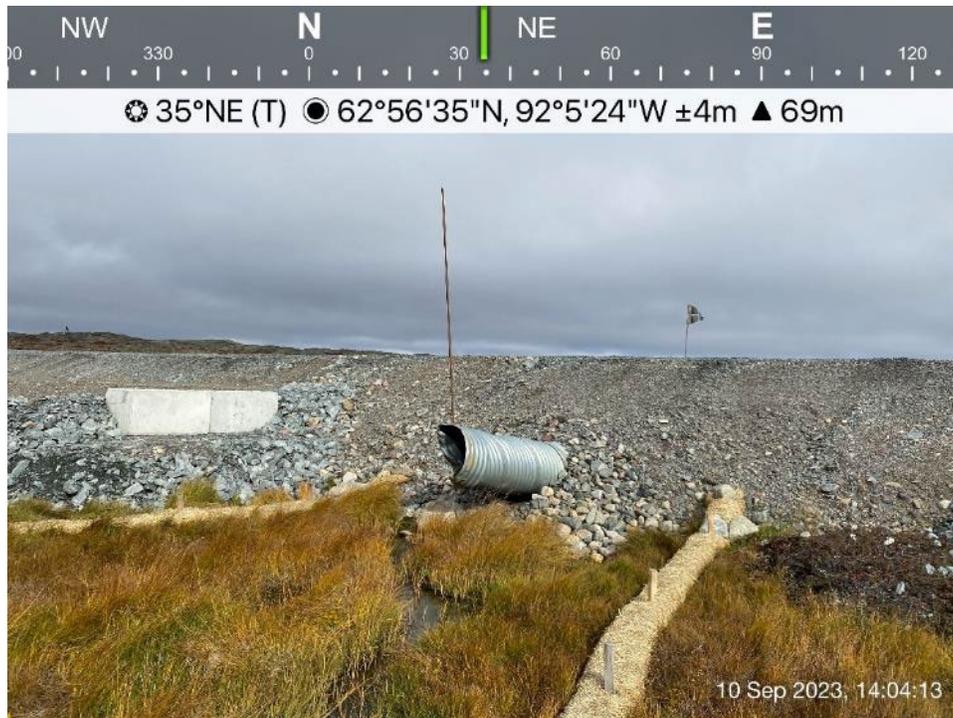
AWAR Road/Culvert - Photo 47: Culvert KM 18.15 – outlet.

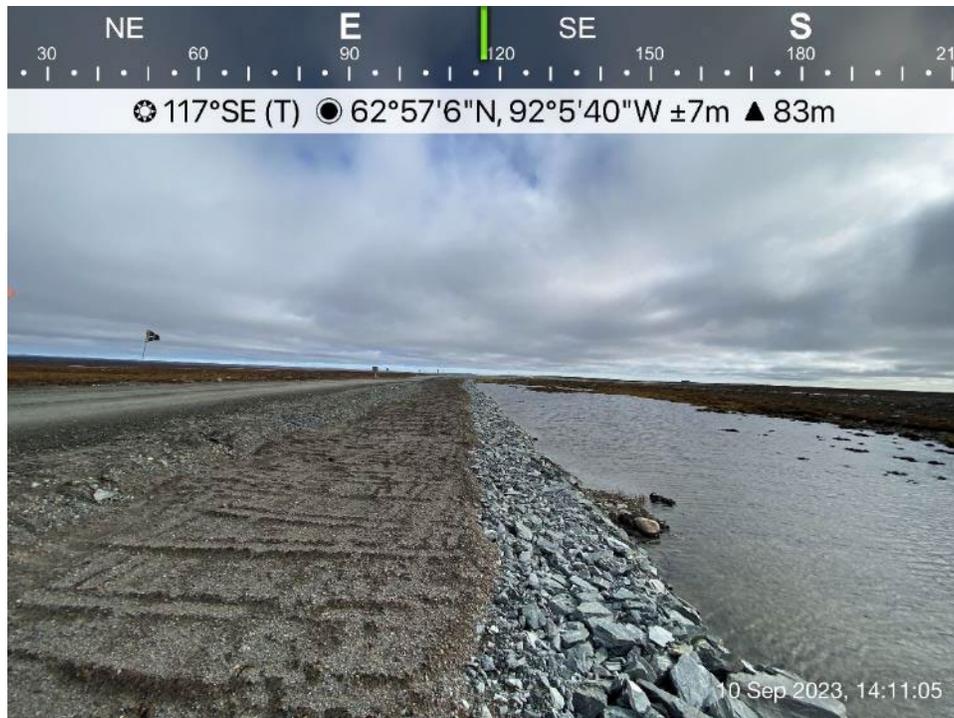
AWAR Road/Culvert - Photo 48: KM 19 - No culvert installed, ponded water upstream, no sign of overflow.

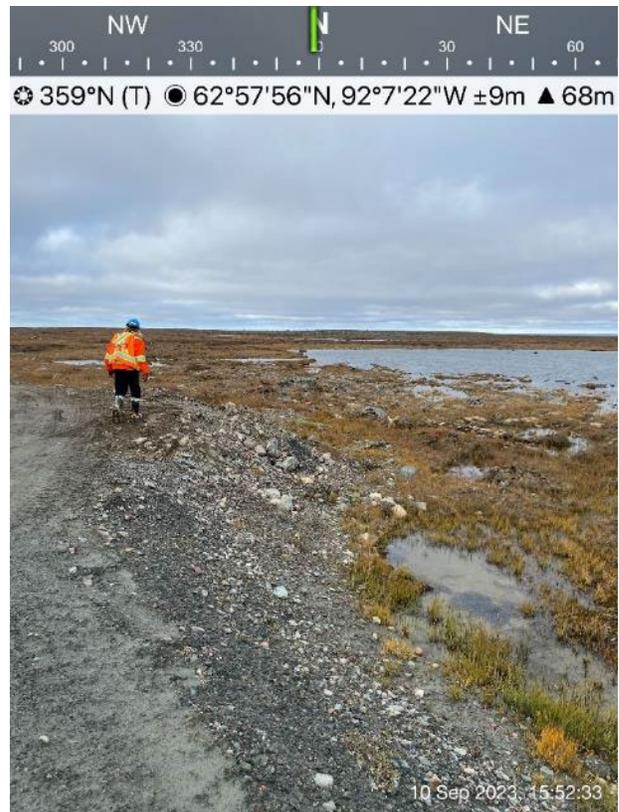
AWAR Road/Culvert - Photo 50: KM 21.0 to 21.5 - No culvert installed, ponded water upstream.

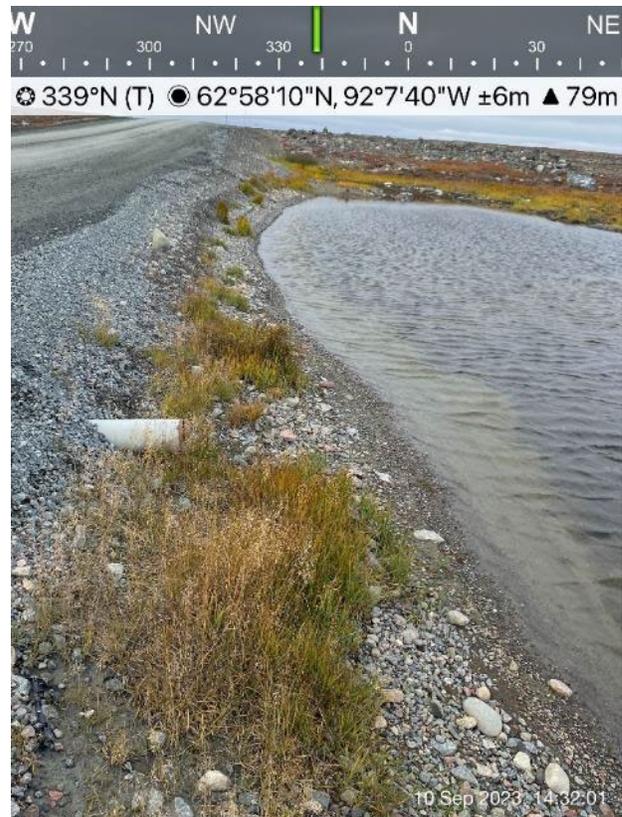
AWAR Road/Culvert
- Photo 52:

Culvert KM 22.3 - steel pipe as culvert, inlet is above water level.

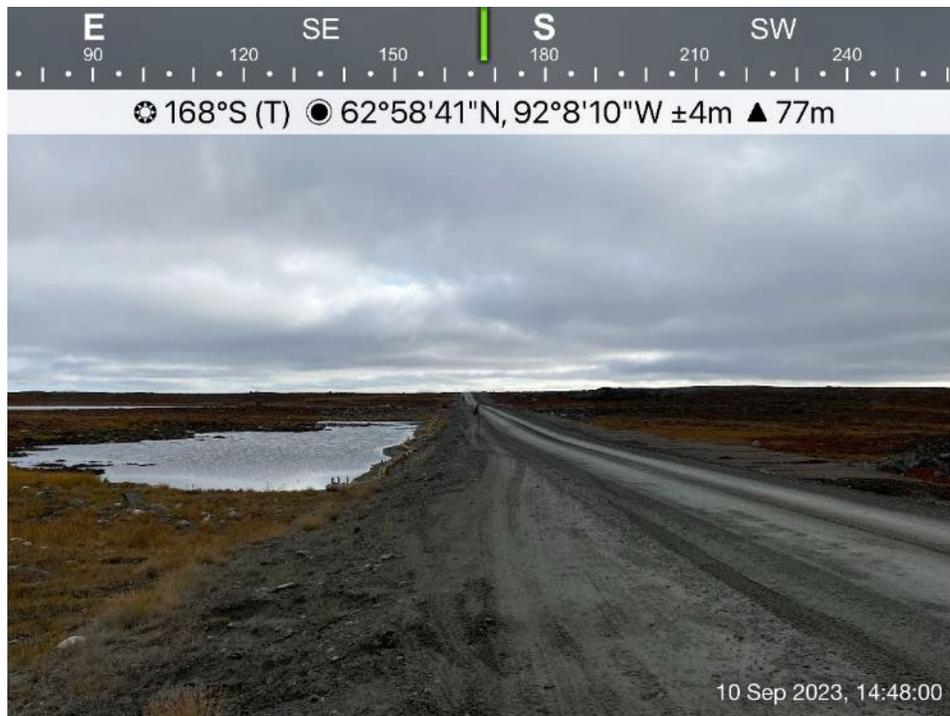
AWAR Road/Culvert - Photo 54:

KM 22.7 to 23.0 - No culvert installed, ponded water upstream.

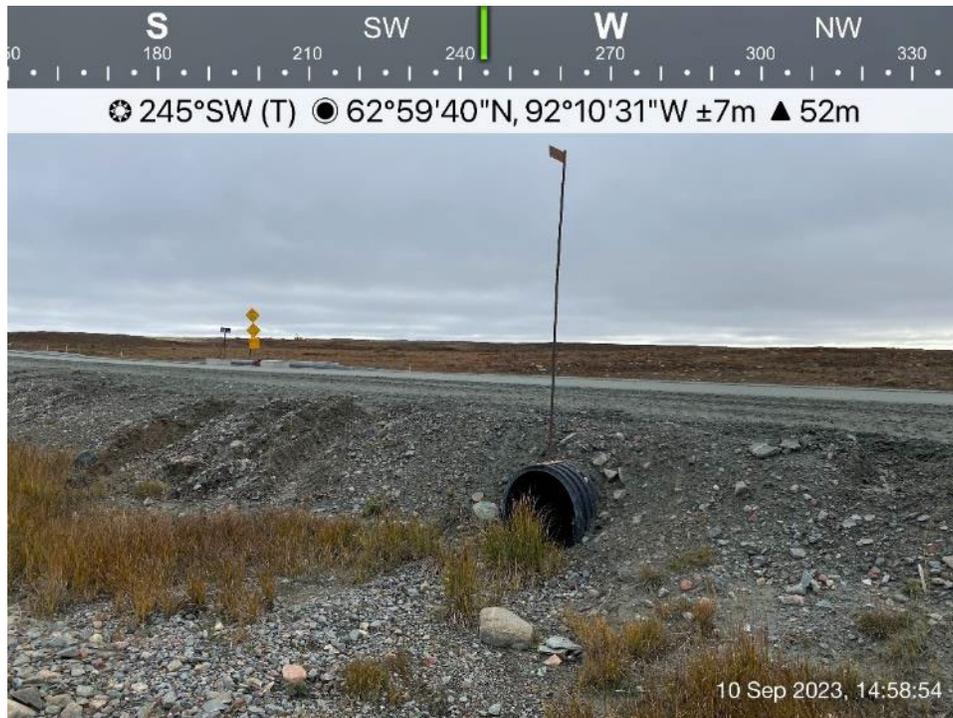
AWAR Road/Culvert - Photo 55: Culvert KM 25.8 - HDPE corrugated culvert – inlet.

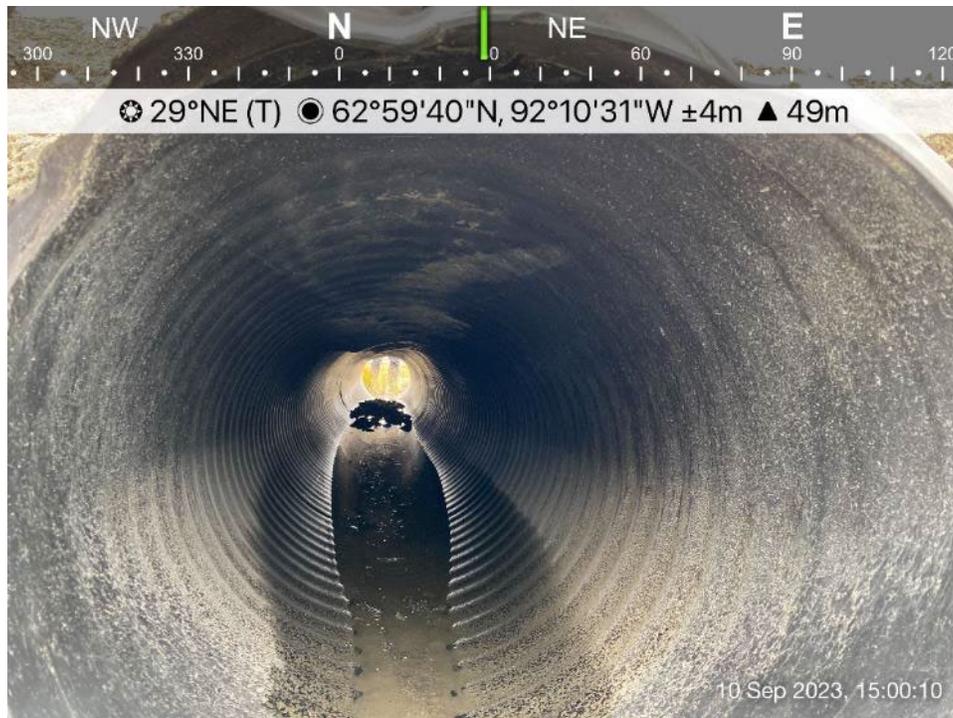
AWAR Road/Culvert - Photo 56: Culvert KM 25.8 - HDPE corrugated culvert – outlet.

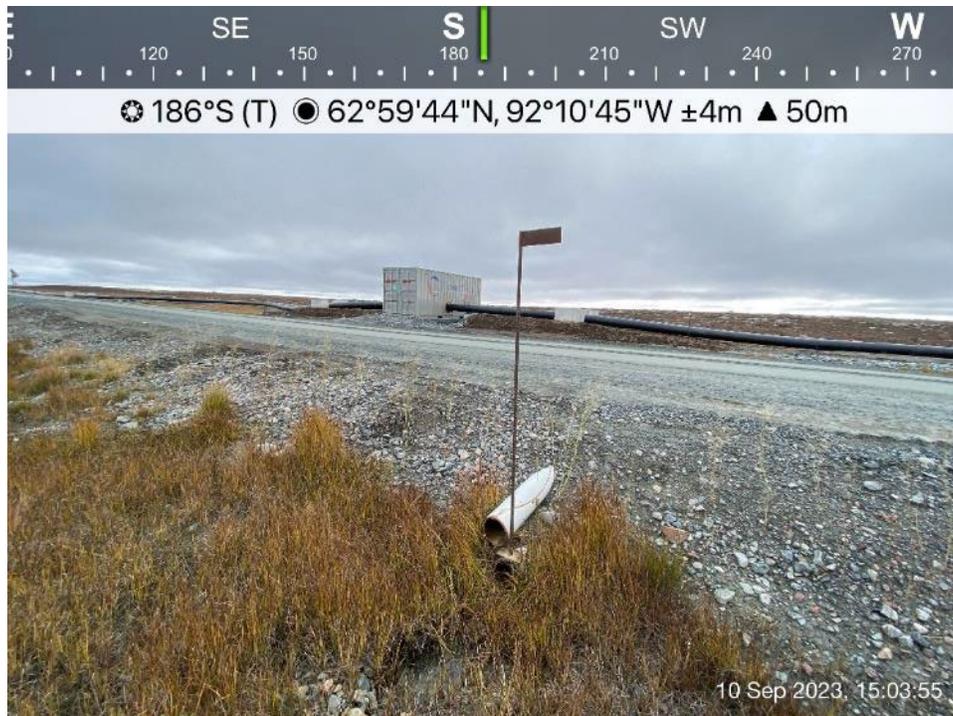
AWAR Road/Culvert - Photo 58: Culvert KM 26.2 - steel pipe as culvert, inlet.

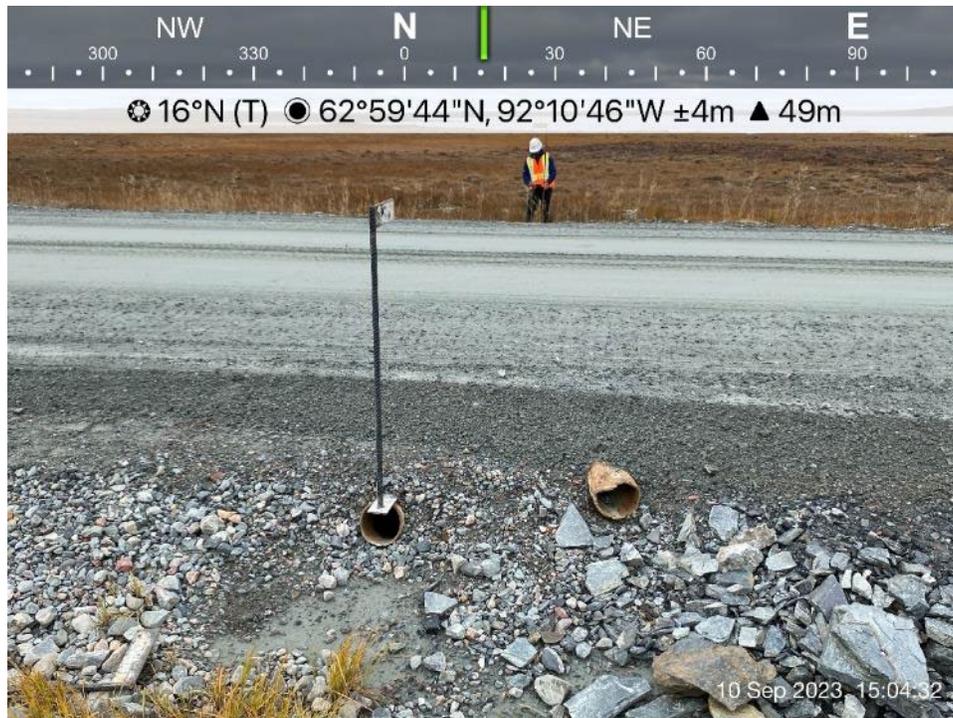
AWAR Road/Culvert - Photo 59: Culvert KM 26.2 - steel pipe as culvert, outlet.

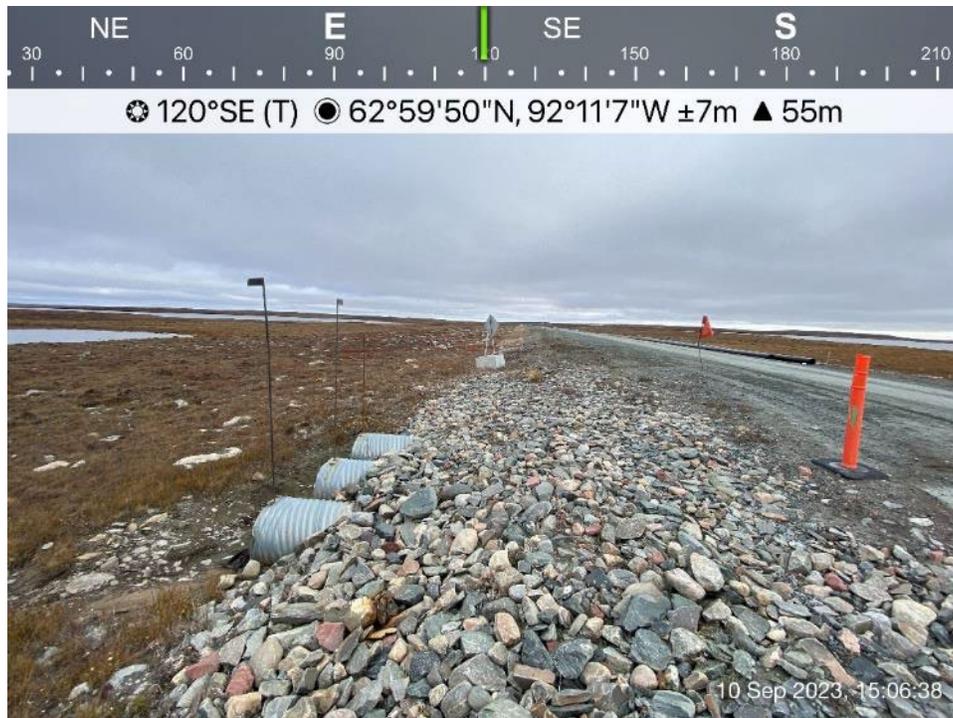
AWAR Road/Culvert - Photo 60: Culvert KM 26.5 – inlet.

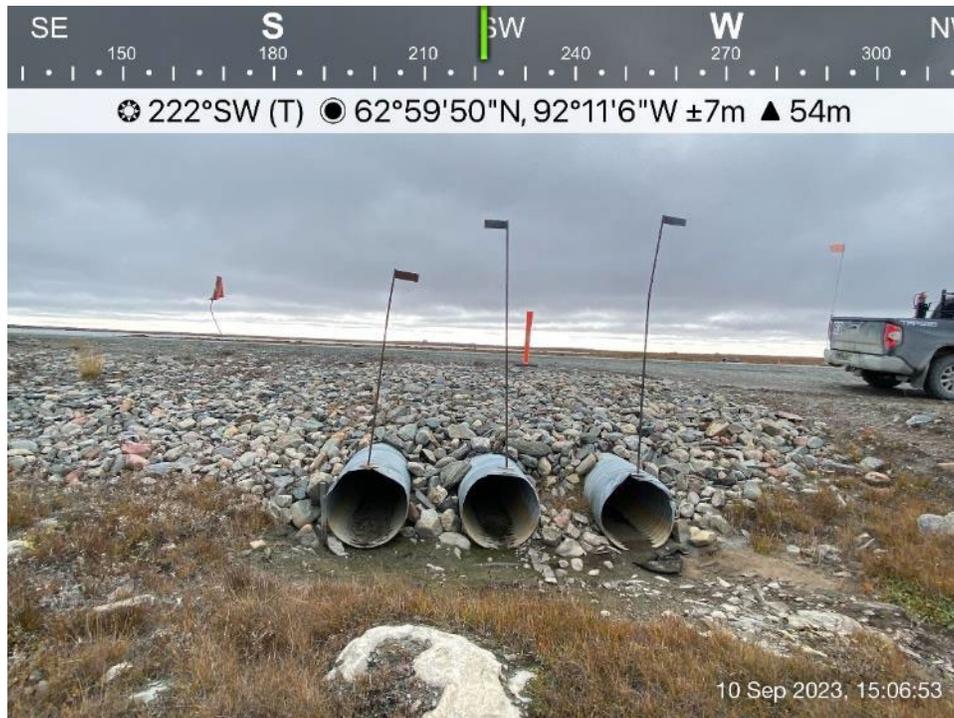
AWAR Road/Culvert - Photo 61: Culvert KM 26.5 – inlet.

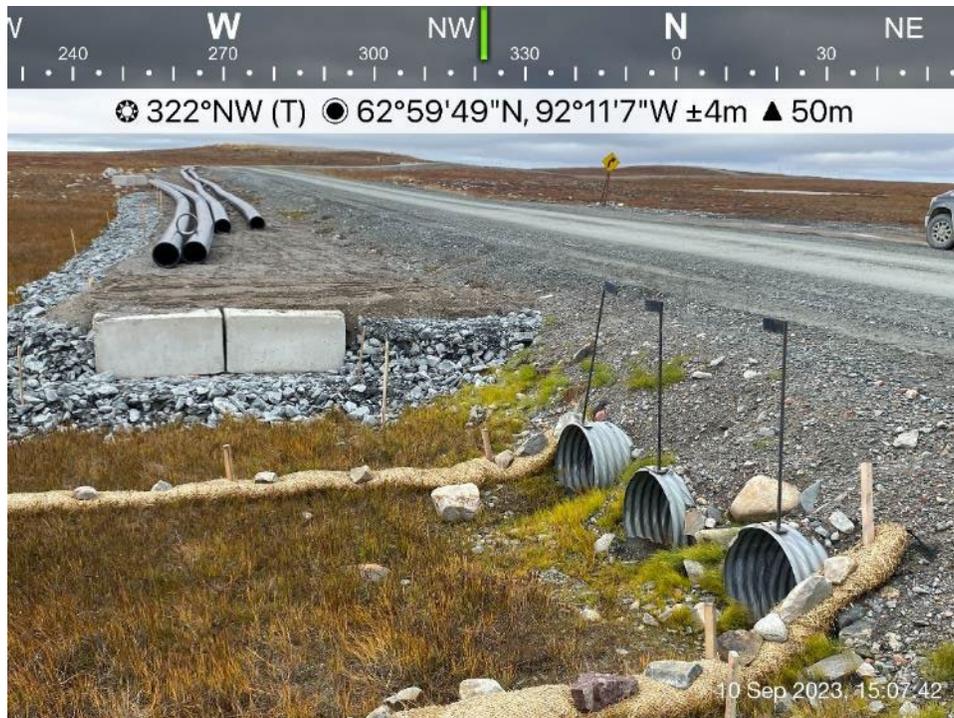
AWAR Road/Culvert - Photo 62: Culvert KM 26.5 – outlet.

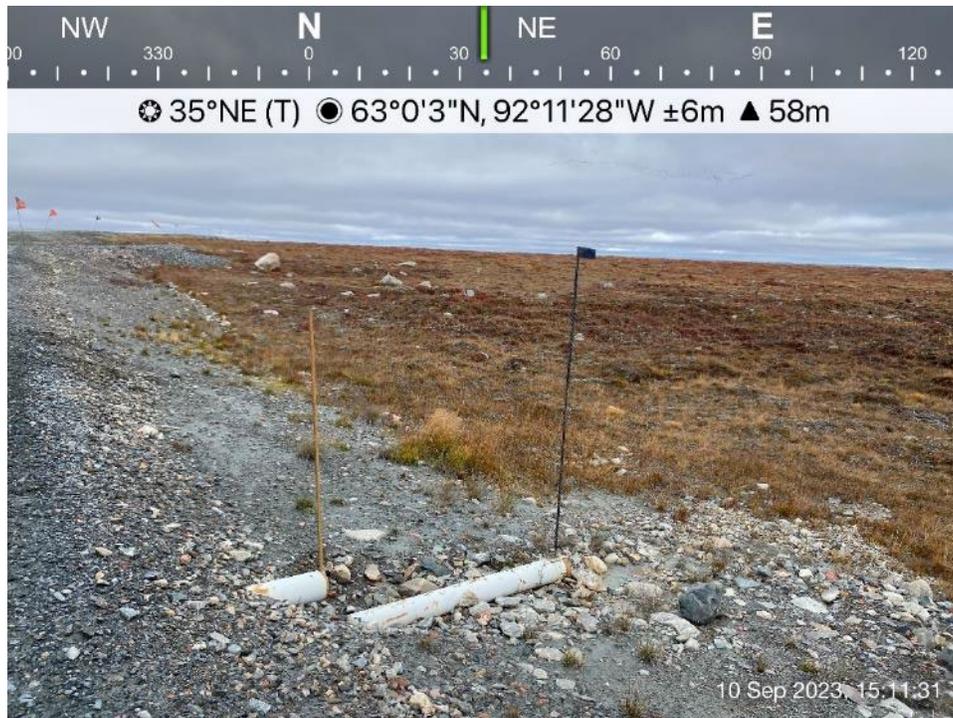
AWAR Road/Culvert - Photo 63: Culvert KM 26.8 - steel pipe as culvert, inlet is above water level.

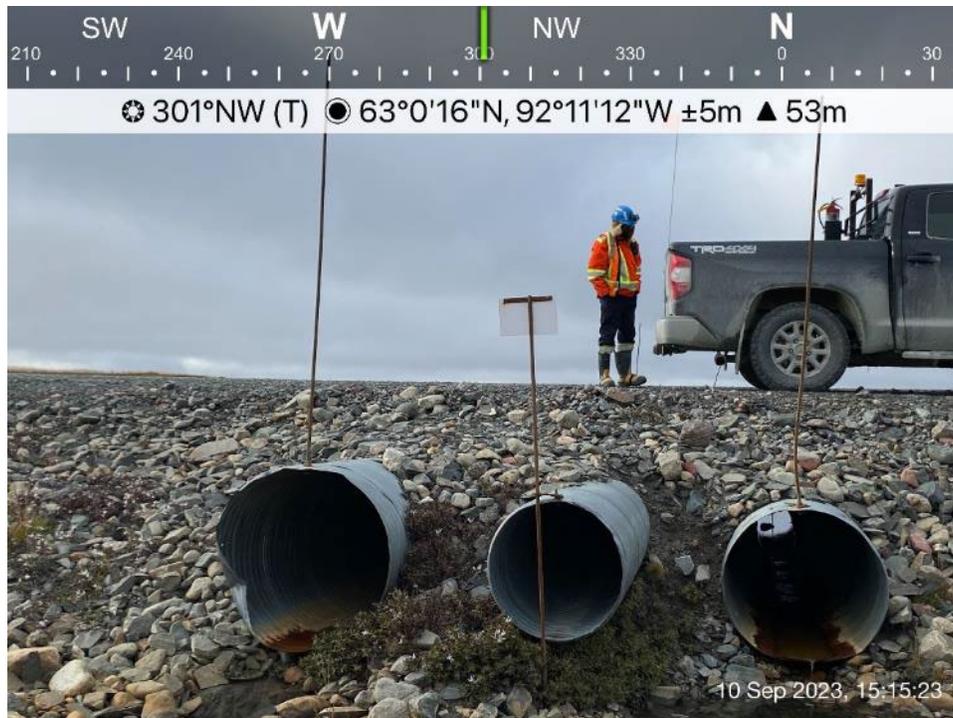
AWAR Road/Culvert - Photo 66: Culvert KM 27.1 – inlet.
