ALL-WEATHER ACCESS ROAD (AWAR)

APPENDIX S

ITIVIA FUEL STORAGE AND BYPASS ROAD

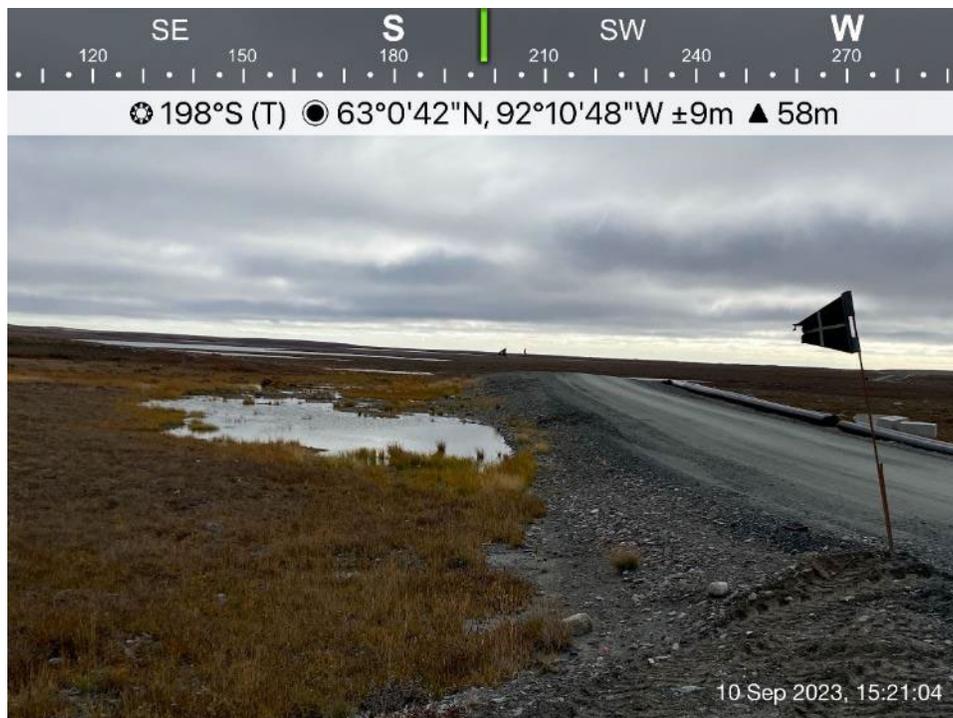
AWAR Road/Culvert - Photo 68: KM 28.7 - No culvert installed, ponded water upstream.

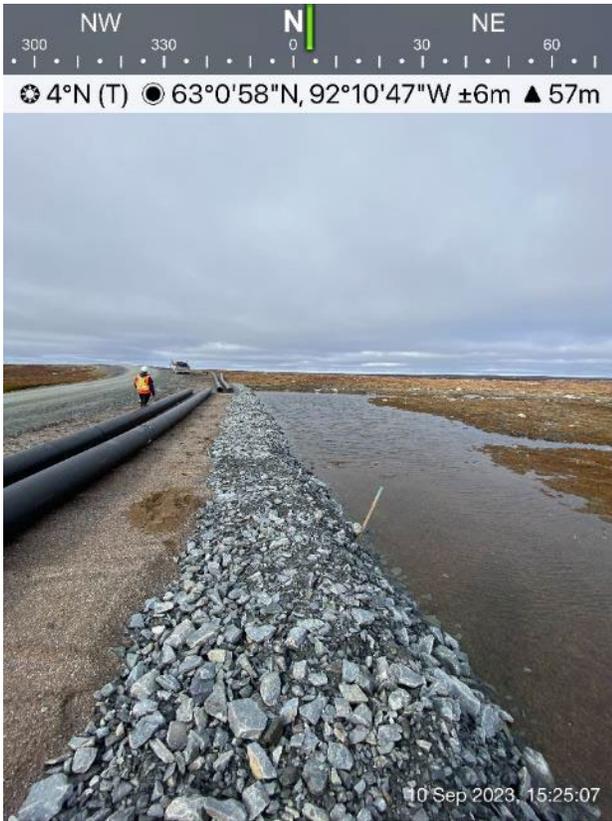
**AWAR Road/Culvert
- Photo 69:**

KM 29.1 - No culvert installed,
ponded water upstream.
