## 2026 Site Visit Report

# DORIS NORTH GOLD MINE & PHASE 2 HOPE BAY BELT (HOPE BAY PROJECTS)

File Nos. 05MN047 & 12MN001  
Project Certificates 003 & 009

Site visit report of the Hope Bay Projects for the 2025-2026 reporting year

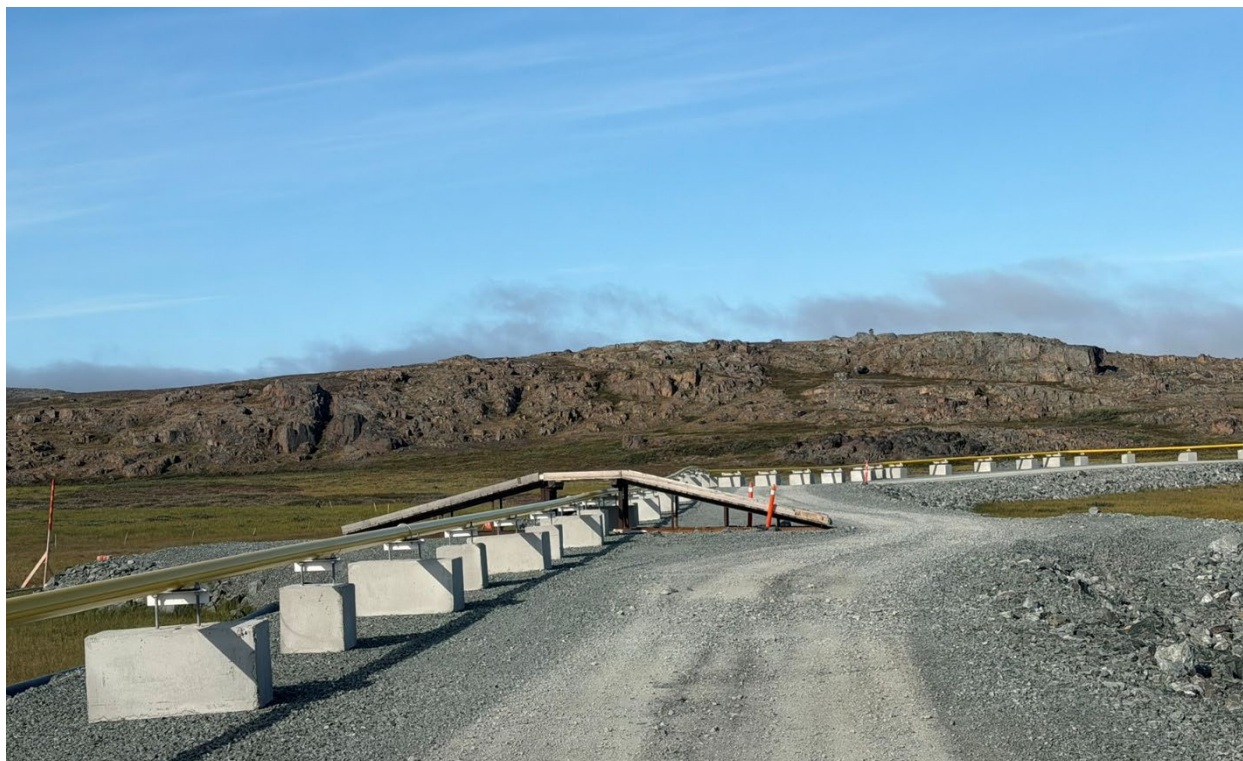
**Photo 9: Designated snowmachine crossing over the rigid fuel line<sup>1</sup>**

<sup>1</sup> The snowmobile crossing at Roberts Bay remains unchanged from 2025. The crossing is deemed unacceptable, as the slope is steep when approaching from the south and the drop-off is too abrupt for safe use. Agnico Eagle is aware of the issue and advised that the crossing will be redesigned.

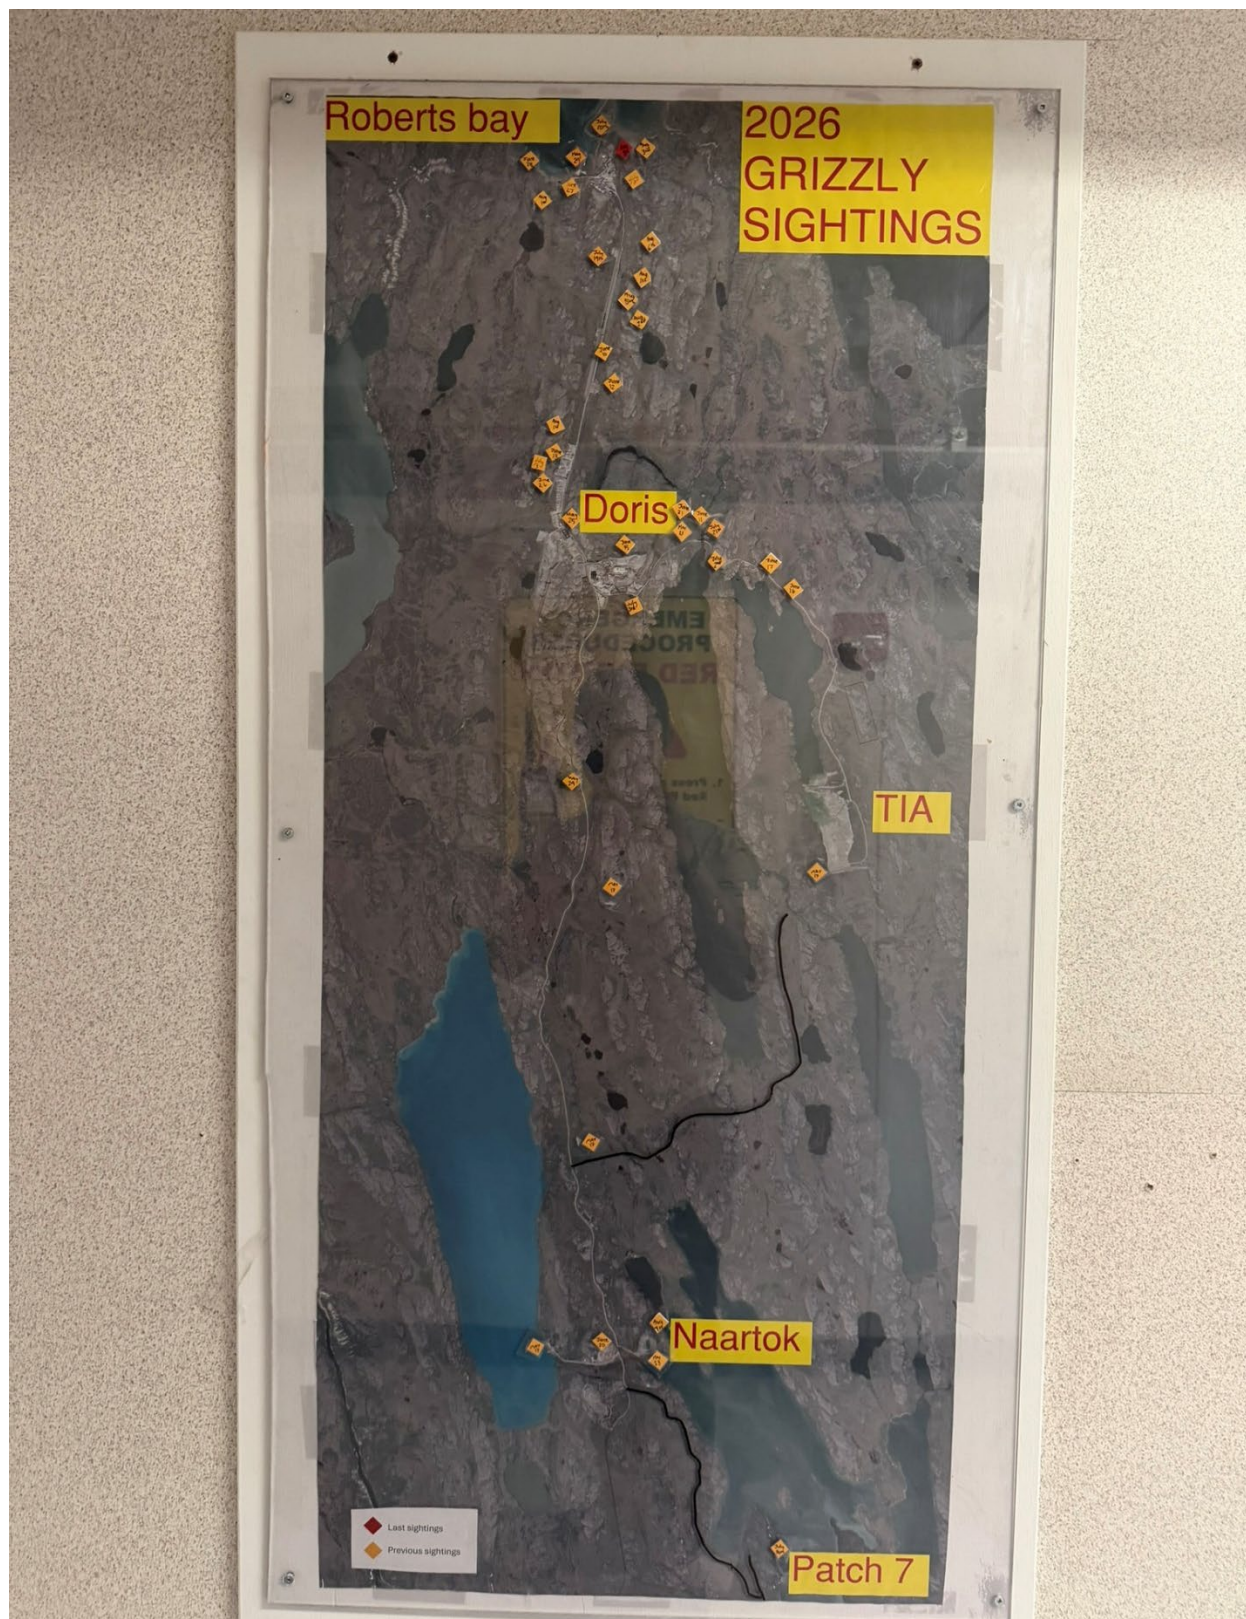
Photo 47: Grizzly sightings map (2026) posted in the camp hallway

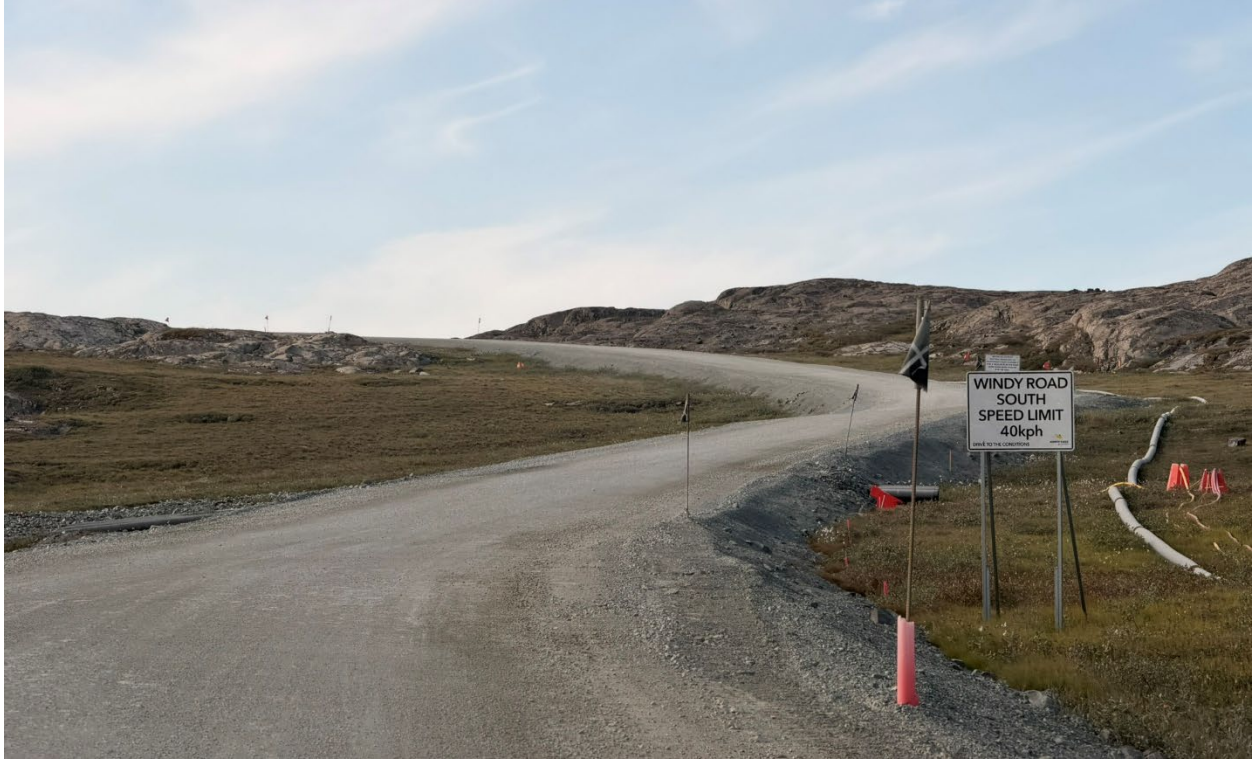
**Photo 64: Doris-Windy All-Weather Road**

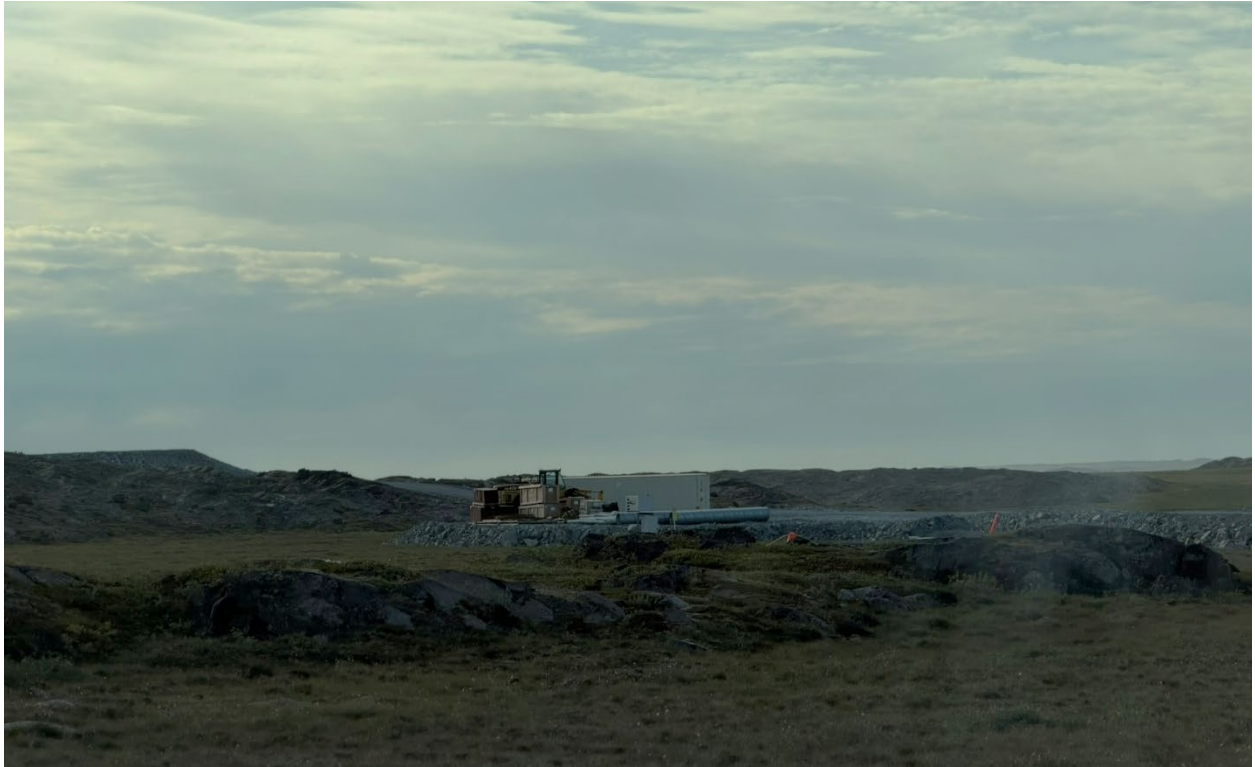
**Photo 66: Wind Turbine 2 Pad**

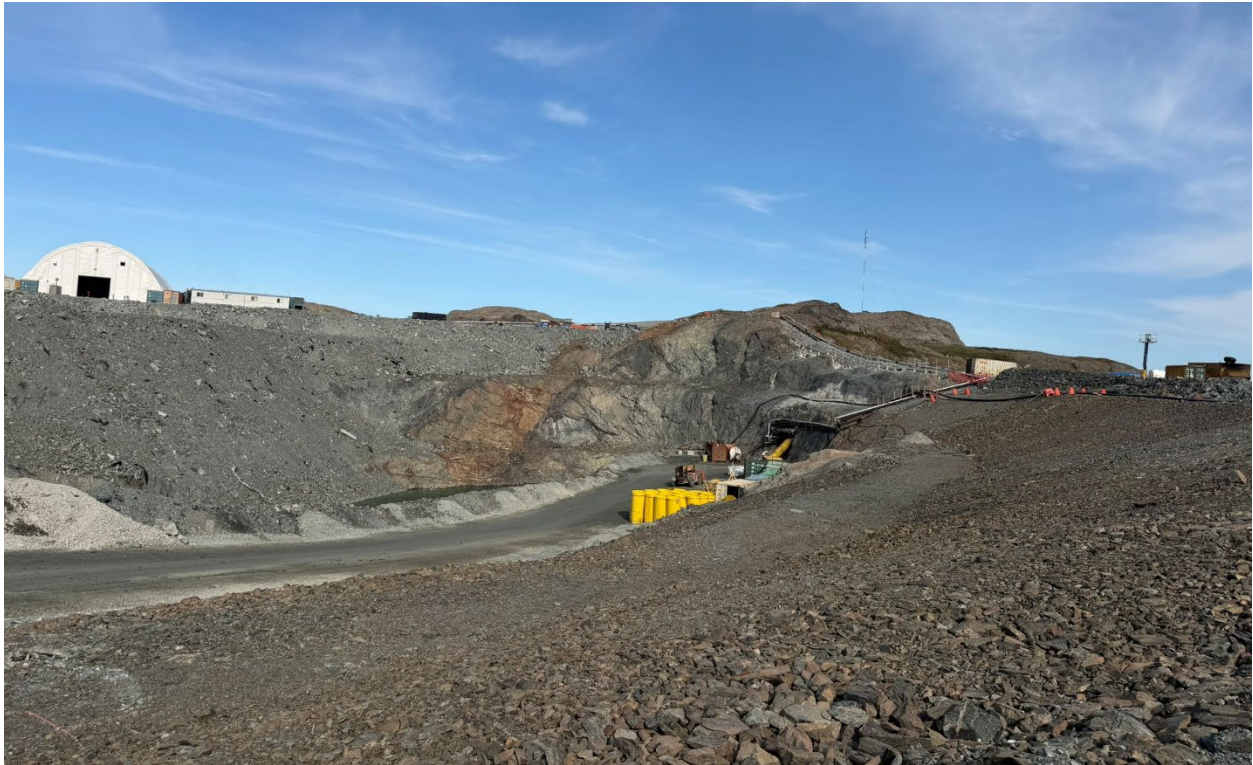
**Photo 71: Naartok East Crown Pillar Pit and Underground Portal**

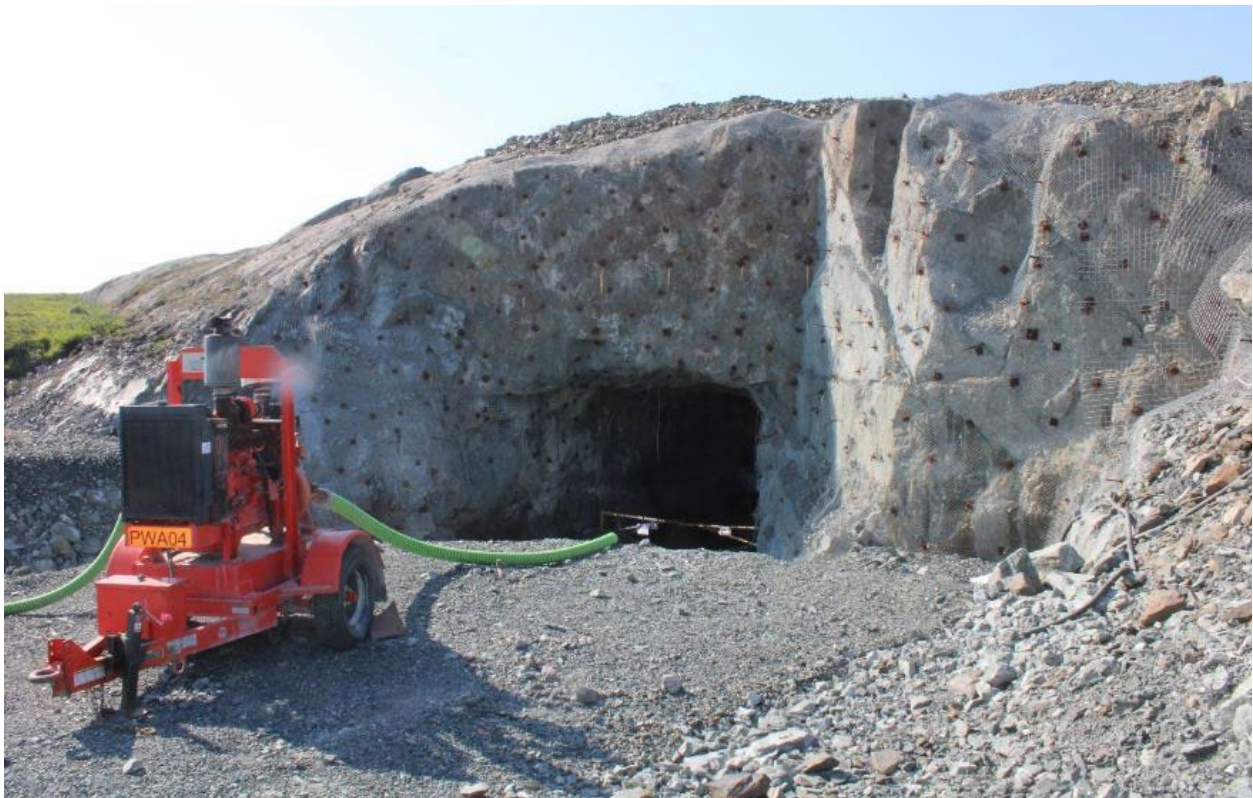
**Photo 76: Former Madrid North Portal (2024)**

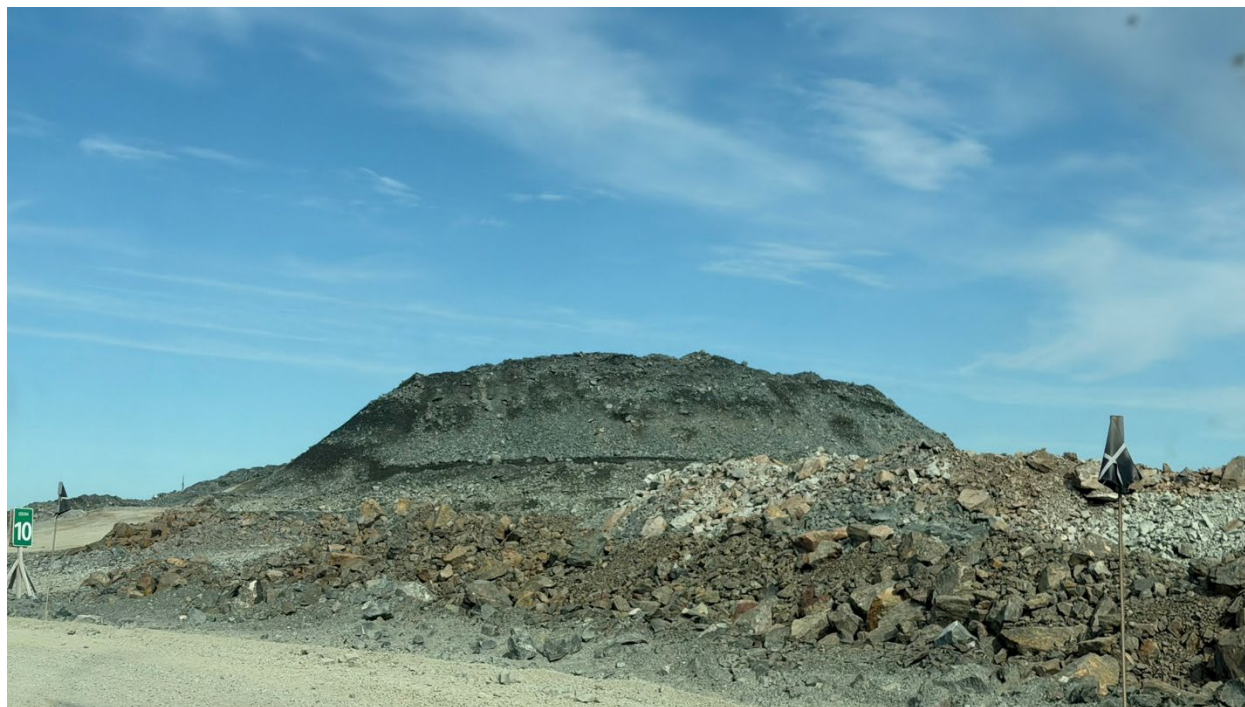
**Photo 78: Madrid North Waste Rock Pile**

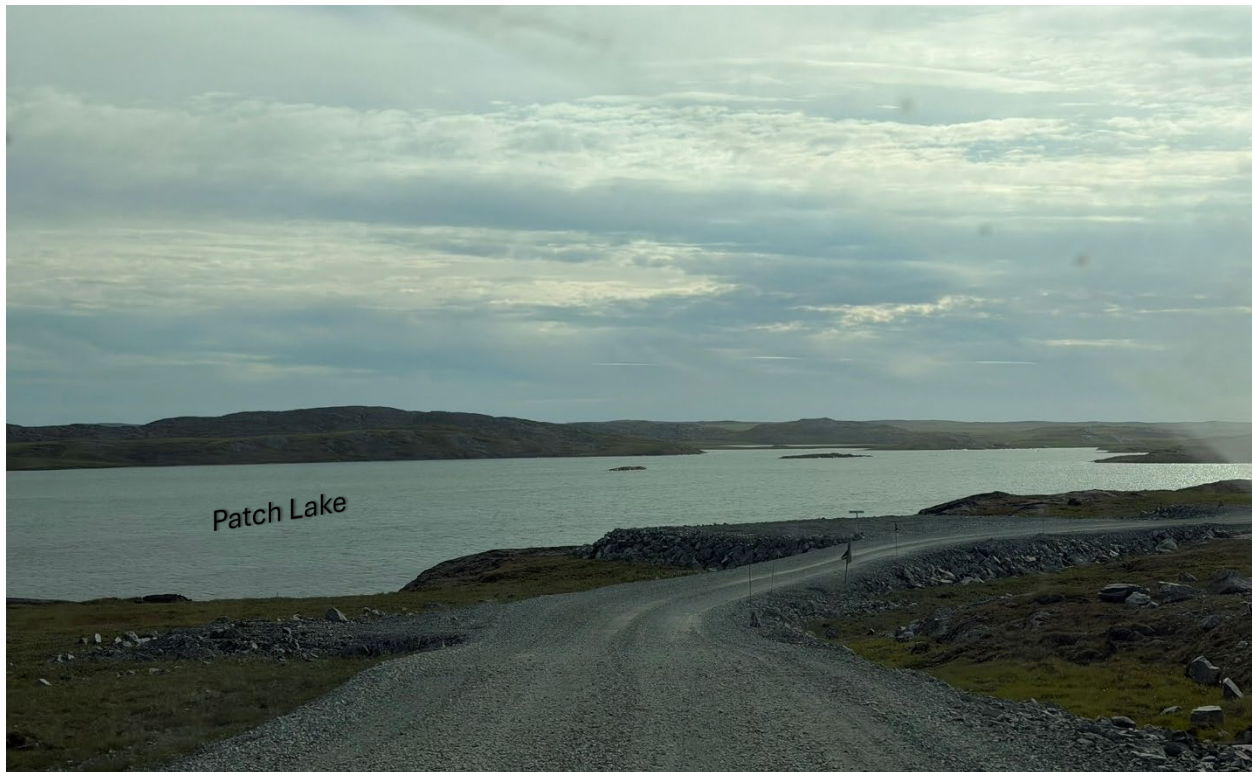
| <b>54</b> | Provide updates on the status of ongoing exploration programs and other related physical activities associated with the Hope Bay Belt Property. | The exploration gravel track and drill pads near Patch Lake were observed, and the continued development of Patch 7 and associated infrastructure was discussed (Photo 81 and Photo 82). |

**Photo 81: Exploration Gravel Track**

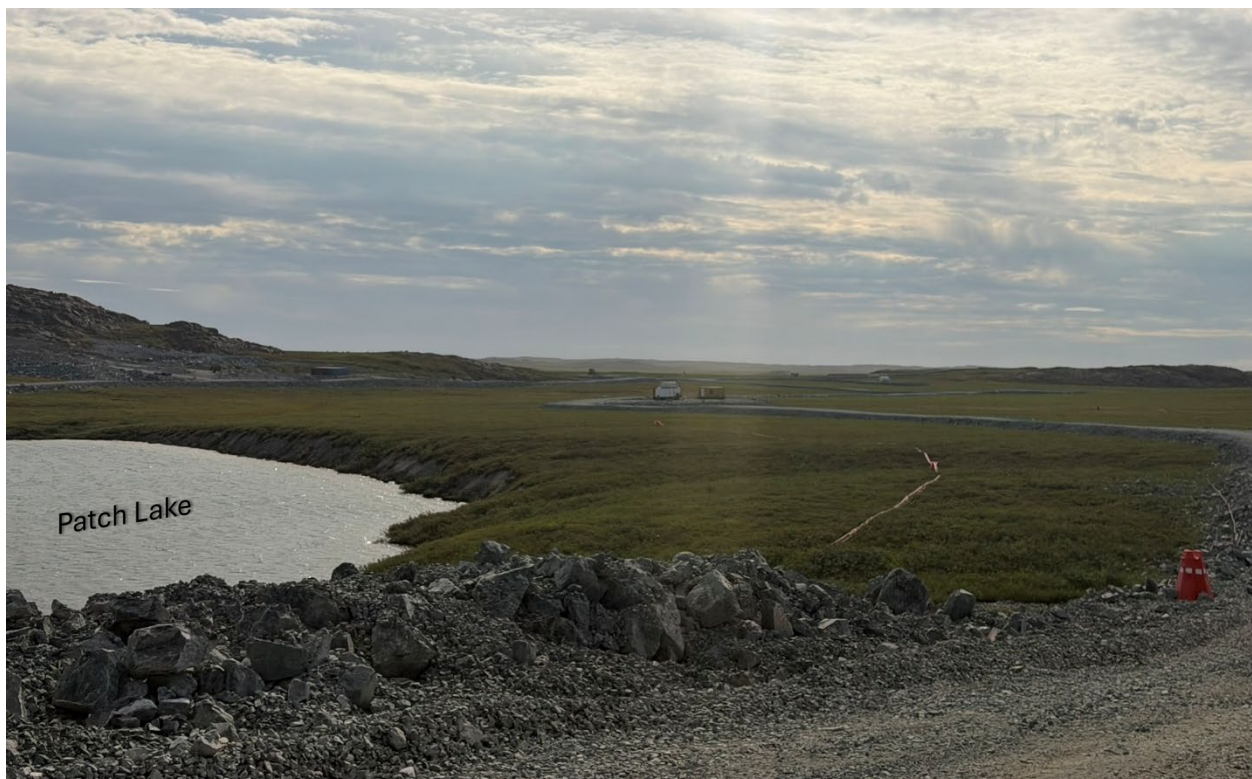
**Photo 82: Exploration Gravel Track – Patch 7 area**
